**RE: City of Fort Saskatchewan Indoor Facilities Services Review: Process update memo #1**

The 2023 Harbour Pool Assessment Report (under separate cover) provides an overview of the current state of the facility. Lead by ACI Architecture and conducted by a multidisciplinary team of engineers and architects, the Report addresses structural, mechanical, electrical, and architectural considerations of the facility and the potential for expansion. The Report also includes an assessment of the aquatics components of the facility interpreted by an aquatics specialist (WTI). This aquatics assessment includes a review of the technical aspects of the natatorium and waterworks and includes some insight on functionality and limitations.

FEBRUARY 10, 2023

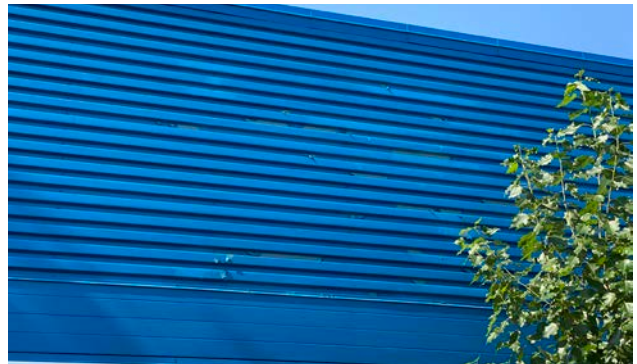
Photo 3 & 4: Delaminating Cladding

The existing metal cladding that has been installed over the original block shows significant signs of deterioration. This includes painting delaminating and exposed raw steel. Replacement of cladding around the perimeter of the original portion of the aquatics facility is recommended. (Refer to *Costing and Facility Condition Analysis Rating in Appendix F Section 4.0.*)

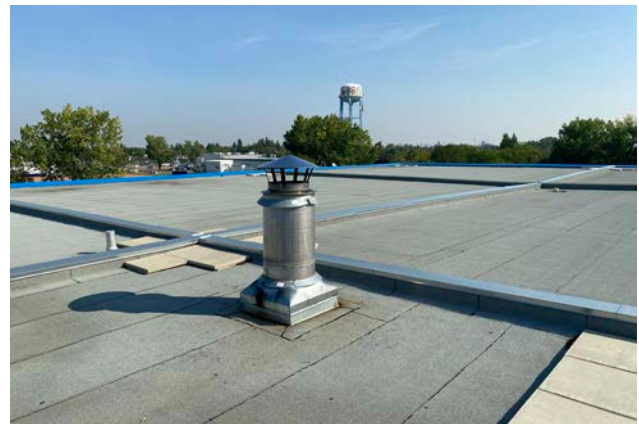
Photo 9-10: Ponding on Roof

The roof on both the original and addition portions are SBS roofing system. In general, the sloping to drain is in acceptable and good condition, however, there are spots where ponding is occurring. Based on discussion with the maintenance facility, remediations have occurred on the lower roof to install additional drains to alleviate some ponding. The ponding in general is minimal and expected on a facility of this age.

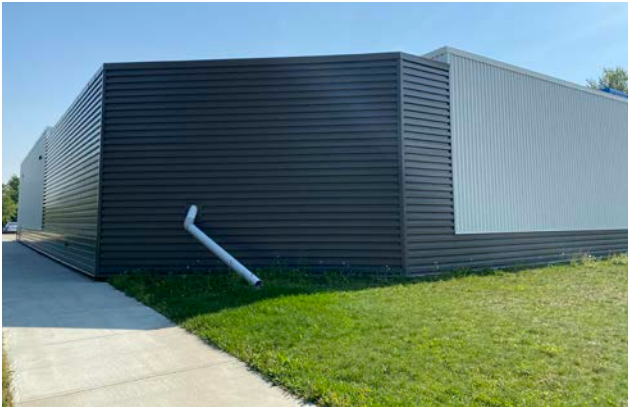
Photo 11: Drainage

completed on the interior of the natatorium to the roof drains due to leaking. Both systems appear to be operating as designed.

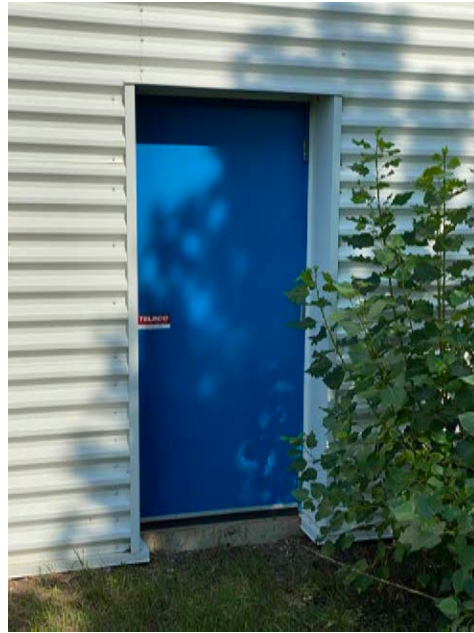
Photo 14: Exit Door with significant drop

The two doors located along the south facade are recommended to have concrete pads installed on the exterior. On both doors there is a significant drop from the door sill to the grade.

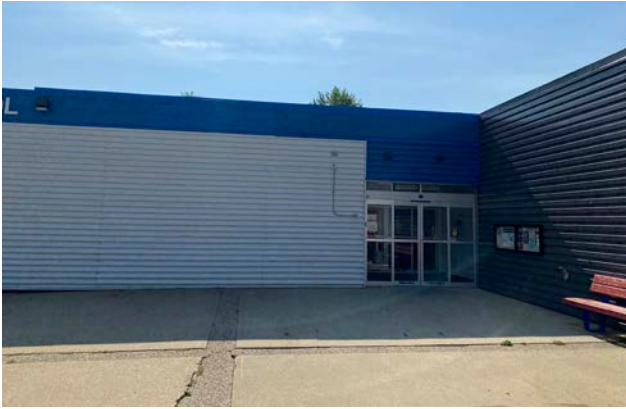
Photo 16: Main Entrance

The main entrance sliding doors located along the north facade upon visual review are in good condition. The operation of the doors is facilitated through motion sensors and evidently to be fully operational.

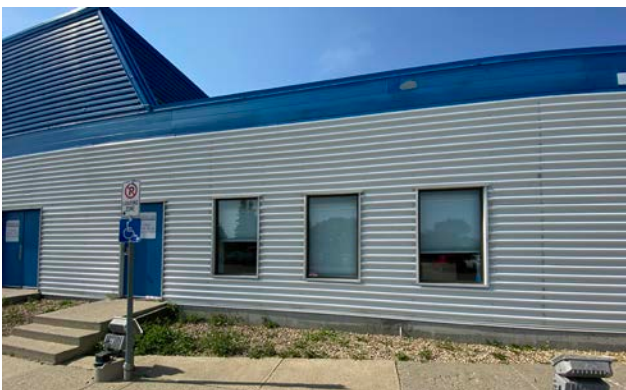
Photo 18: Exterior Windows

The majority of the windows located within the original natatorium space were replaced in 2010. Upon visual inspection, the windows to be in good condition. The flashing around the perimeter of the windows is in good condition.

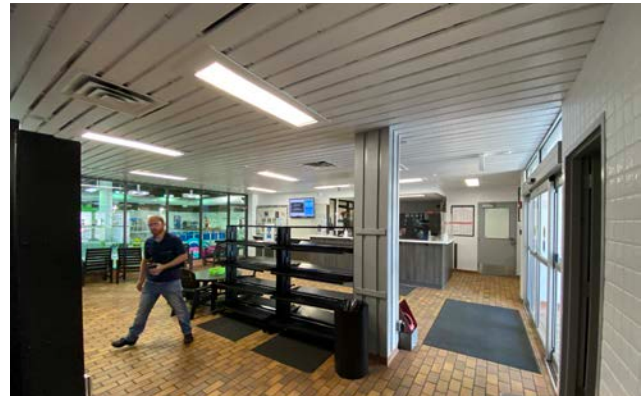
Photo 19: Main Lobby

Upon visual review, the finishes are the original floor tile, wall tile, wood slat wall panels, and slat ceiling. The lobby area demonstrates evidence of renewal. The ceiling and tiles were painted within the last 3 years.

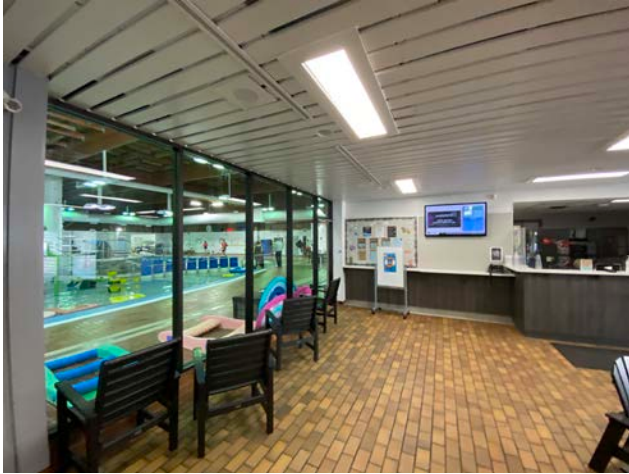
Photo 21: Natatorium Viewing Area

handling to properly function, as the pool natatorium operates with negative pressure and the administration areas operate with positive pressure. The excessive humidity was also causing damage to office equipment, and sound transmission from pool to administration area was not ideal.

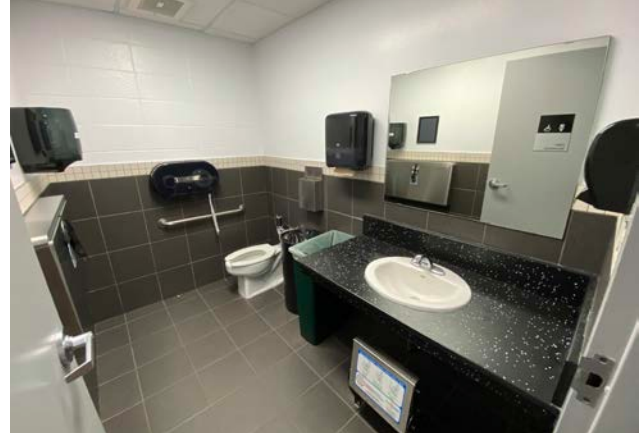
Photo 23: Public Washrooms

sink perimeter, and toilet base would be recommended.

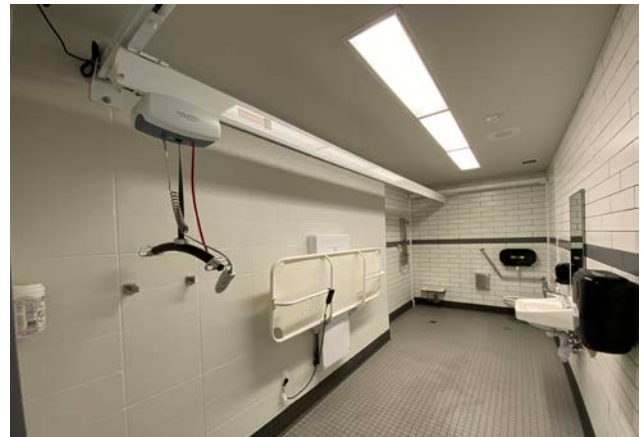
Photo 24: Accessible Washrooms

The Accessible Washroom was installed as part of the 2019 addition. The room consists of a toilet, barrier free sink, shower, and electronic change table. Review of the accessible washroom is in excellent condition.

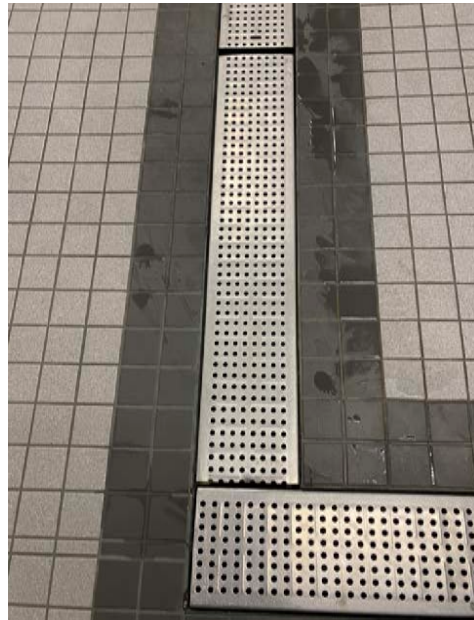
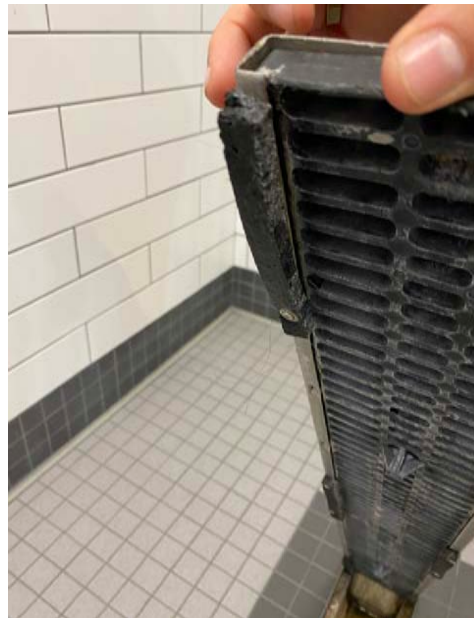
Photo 28-29: Change Room drainage

and exposed edges. The recommendation is to replace the current drainage to a grate system with proper seal to allow for level transition and no exposed cut edges. *(Refer to Costing and Facility Condition Analysis Rating in [Appendix F](#) Section 5.0.)*

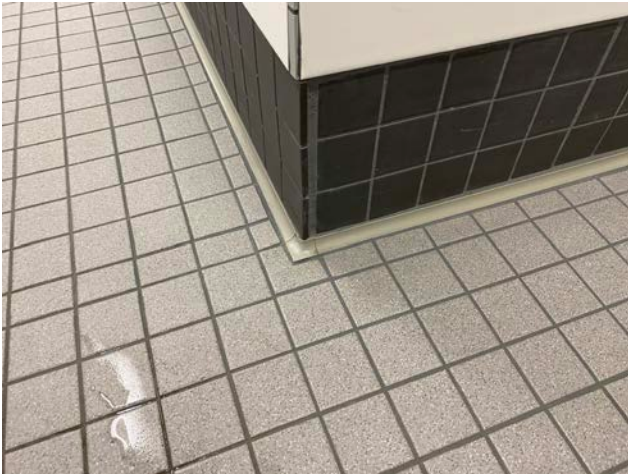
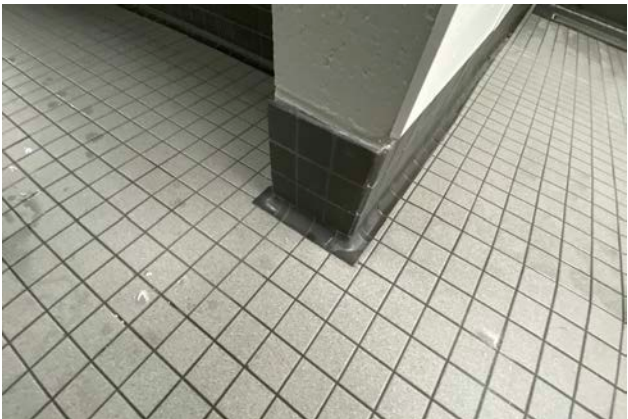
Photo 30-31: Cove Base in Change Rooms

The tile base around the perimeter of the change rooms differs depending on the room. For the universal change room the tile consists of a cove base, however, in the other two rooms, a separate cover has been added to wall base. This cover shows signs of deterioration and dirt collection. Based on a discussion with the operators, the tiles within the men's and women's change room were floated. This created a problem where cove was noted as not possible. Recommendation to review possible cove options with a tile supplier to eliminate separate cover system.

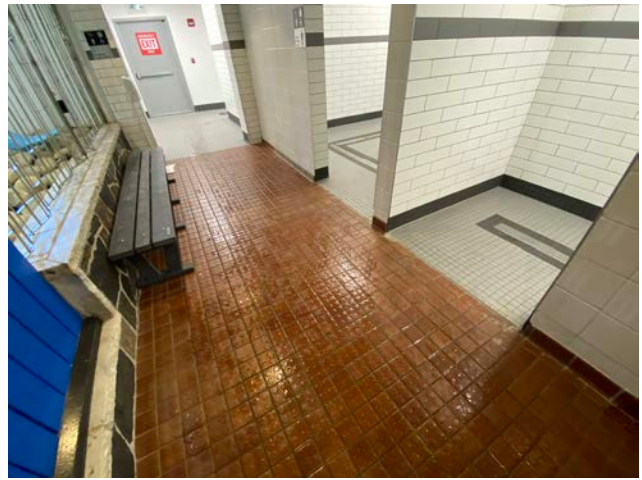
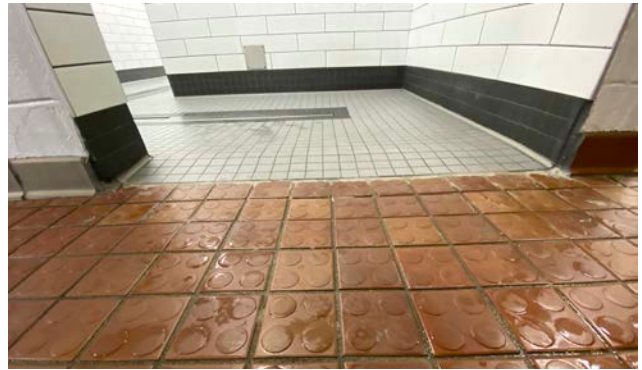
Photo 32-33: Change Area Floor Tiles

Due to the floated tile floor, there are major concerns where the men's and women's change room enter the natatorium area. Because of the thickness at the base on floated tile flooring, there is a ledge created at the entrance of the change room that does not allow water to drain. The drains are located within the change rooms. This results in water pooling on the natatorium side and creates a safety concern around slips and falls. Recommendation would be to investigate floating tile and possible drainage solutions.

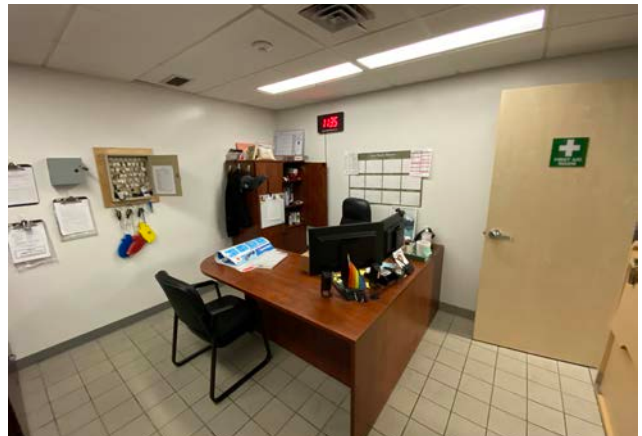
Photo 34: Staff Area Office

Overall the administration area appears to be in overall good condition. The tile floor matches the replaced reception area. The walls and ceiling in the administration are reviewed to be in good condition, minor damage is noticeable.

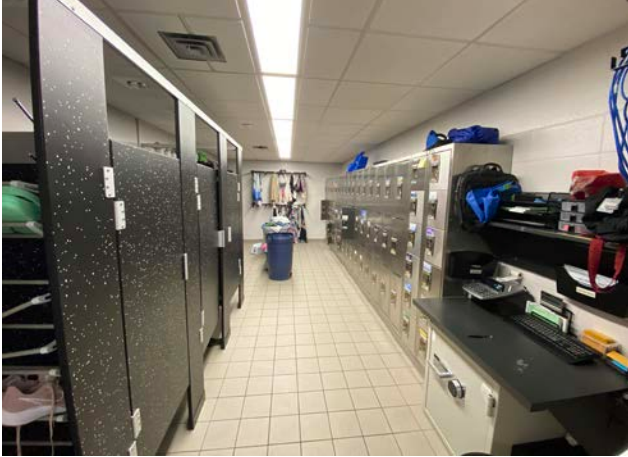
Photo 35: Staff Locker Area

Lockers and changing enclosure partitions within the staff change is visually inspected to be in good working condition. One recommendation is to extend the change room partitions to full height walls to allow for more privacy. *(Refer to Costing and Facility Condition Analysis Rating in [Appendix F](#) Section 5.0.)*

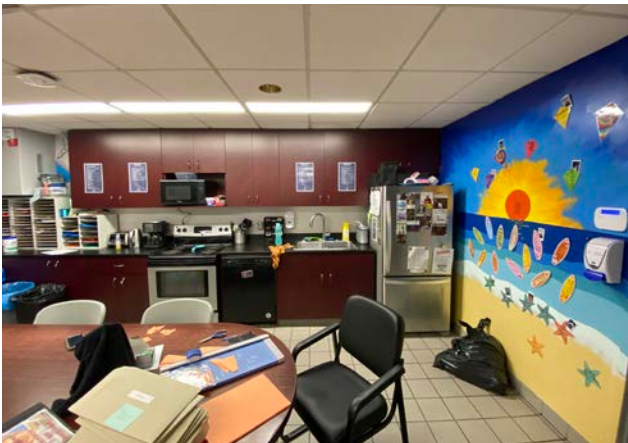
Photo 36: Staff Room

Millwork within the staff area is inspected to be in good condition. The doors within the Staff Area are also wood and in good condition.

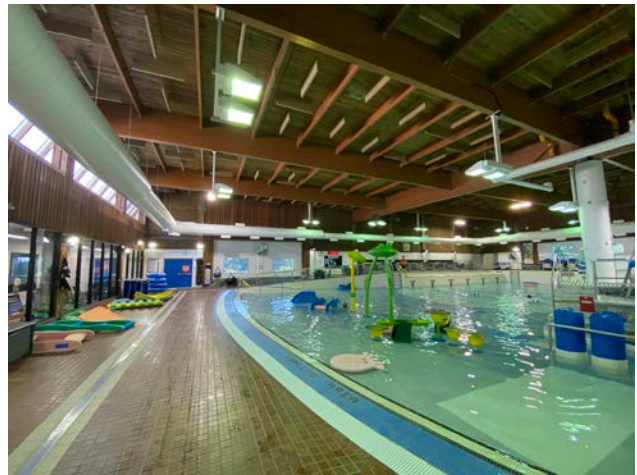
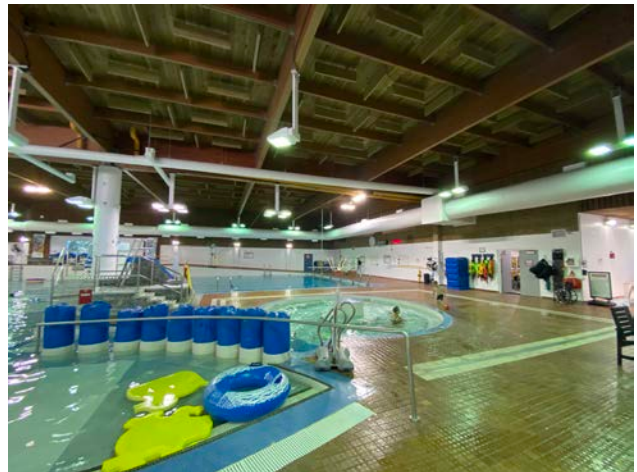
Photo 37-38: Natatorium Area

The Natatorium areas contains tiled floor decks, a mixture of wood wall slats, stone veneer walls, concrete block, and exposed wood roof deck with glulam beams. Acoustical baffles have been installed between the glulam beam system.

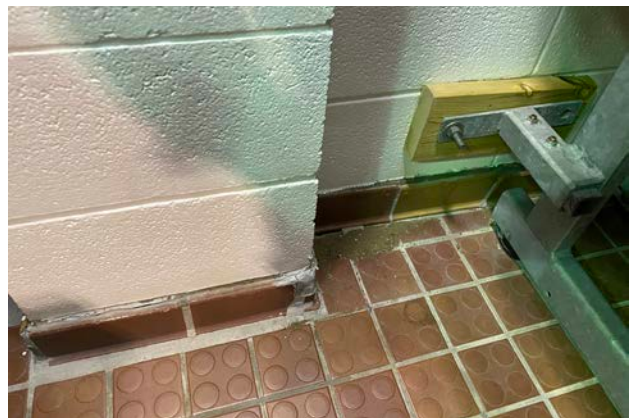
Photo 39: Damaged Base Tiles

The visual inspection indicates tiled floor deck to be in acceptable condition. There are multiple areas that remediation work that had been completed over the years based on drainage and tile failure evidence. The majority of the tiles are in good condition, however minor damage can be visually seen mainly on the base tiles and at grout lines. The recommendation is to repair damaged tiles immediately and within 10 years replacement of entire deck tiles. *(Refer to Costing and Facility Condition Analysis Rating in [Appendix F](#) Section 5.0.)*

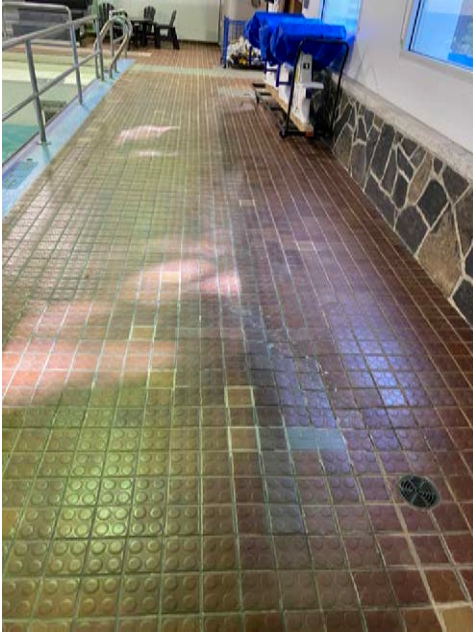
Photo 40: Delaminated Floor

Along the south deck, there is an anomaly within the floor tile between the two existing deck drains. There is visual evidence that the concrete deck has been altered to create a drainage path for the water to access the drains. Concerns over tripping are minor, but the recommendation is to explore alternative options to achieve the deck drainage.

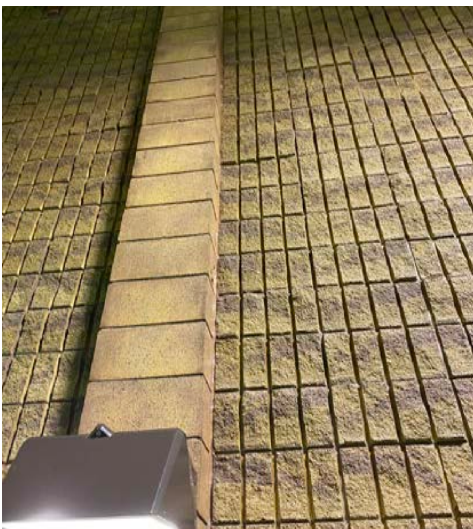
Photo 41: Stone Veneer

The wood slat walls, stone veneer, and exposed concrete block walls is in excellent condition. As noted previously, there is caulking located between the block walls and concrete columns. The recommendation is to have the caulking be replaced regularly to avoid water penetration. There are areas of water penetration within the wood slats. The recommendation is to investigate occurrence and repair as required.

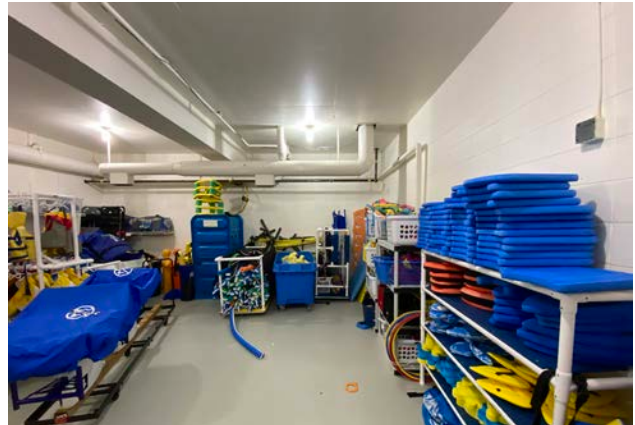
Photo 42: Natatorium Storage

Natatorium storage is accessed from the east portion of the natatorium. The storage room consists of epoxy coated floor, painted concrete ceiling, and painted concrete block. The room finishes are visually inspected as good condition.

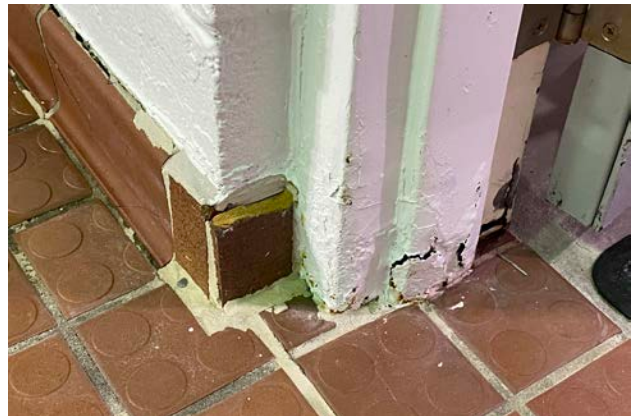
Photo 43: Corrosion on Door Frame

The door access from the natatorium is painted metal door with pressed steel frame. There is significant visual corrosion around the base of the pressed steel frame, which was installed from original construction time period. The recommendation is to repair/replace the damaged frame. The adjacent natatorium base tile requires replacement.

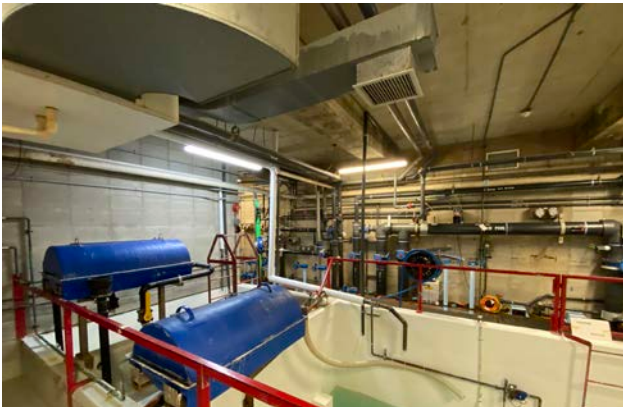
Photo 44: Mechanical Area

The Main Floor Mechanical Room consists of exposed concrete floor complete with a catwalk installation, exposed concrete ceiling, and exposed concrete block. The room finishes are in good condition.

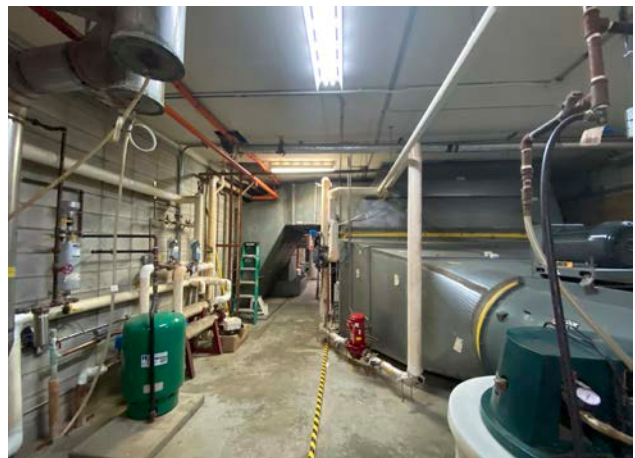
Photo 46: Mechanical Area

The second floor mechanical room consists of the building mechanical units. The room consists of exposed concrete floor, painted gypsum board ceiling, and exposed concrete block. The room finishes are in good condition.

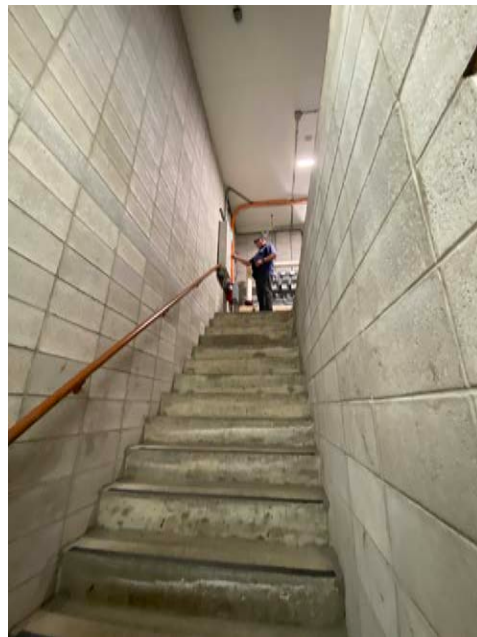
Photo 47: Stairs in Mechanical Area

The stair access to the second floor mechanical room are steep. Based on the construction year, the stairs are acceptable and considered "grandfathered". However, if major modernization was to occur, the recommendation is to replace the stairs with code conforming rise and run.

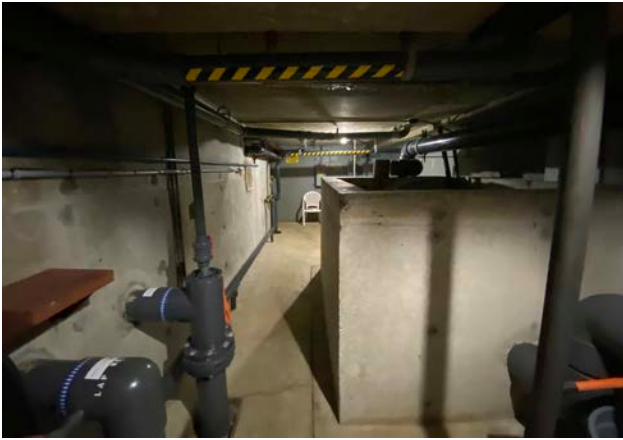
Photo 48: Basement Area

cracks, **refer to structural assessment of this document.**

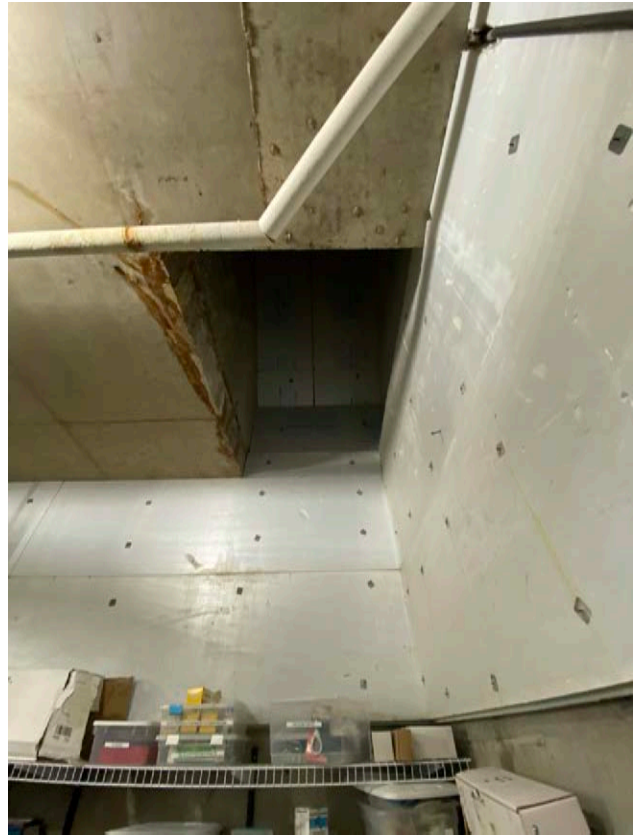
Photo 56: Water Staining

penetration. Recommendation is to investigate staining and water penetration and remediation.

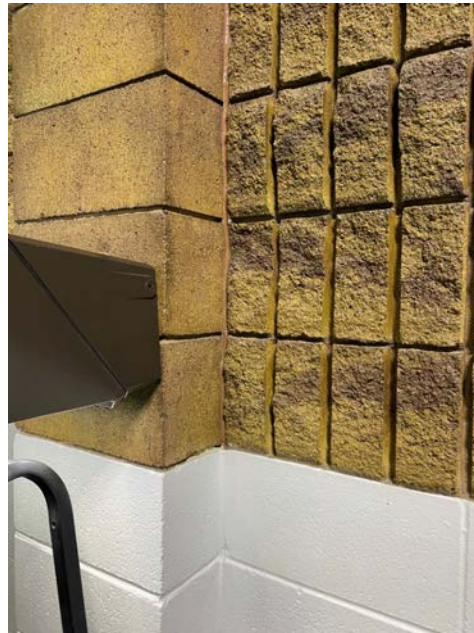
A joint on the east wall appears to have been caulked (Photo 2). No additional cracking was noted in this area.

Photo 2: Caulked joint on east wall

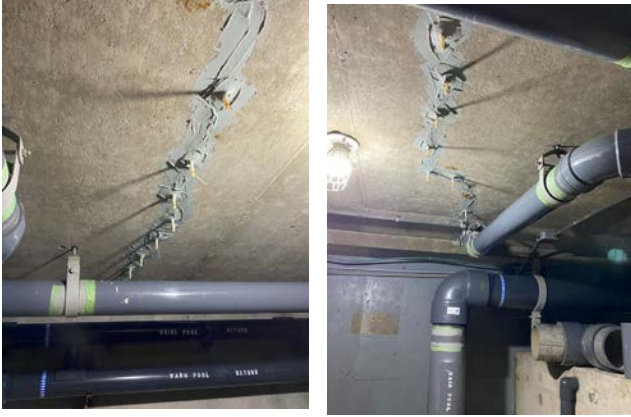
Photo 3 & 4: Repaired cracks on the underside of the pool deck structural slab

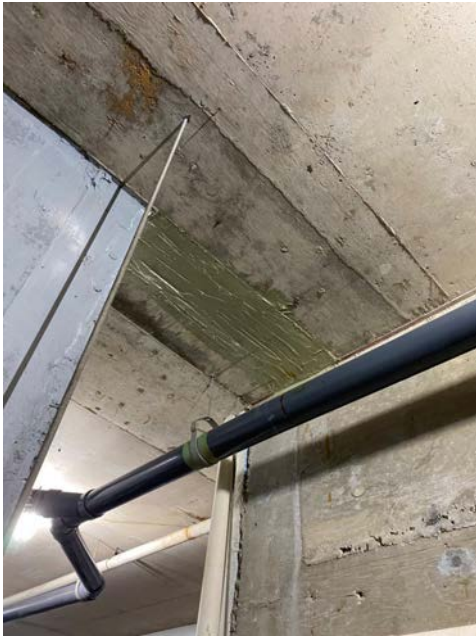
Photo 5: Repaired crack in storage room

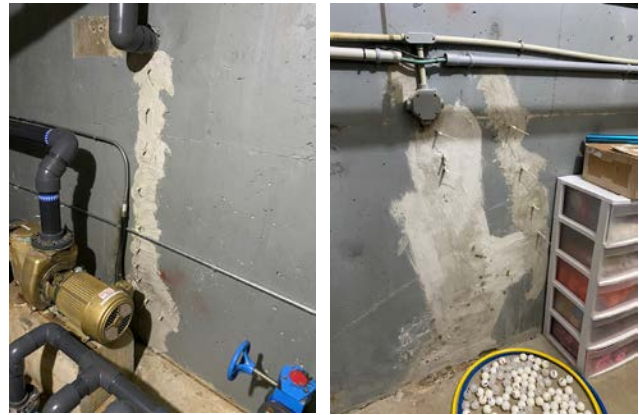
Photo 6 and 7: Repaired cracks in the pool tank walls

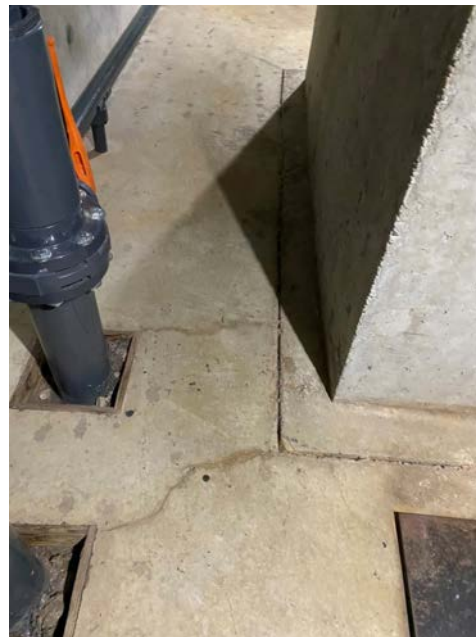
Photo 8: Cracking in the basement slab-on-grade

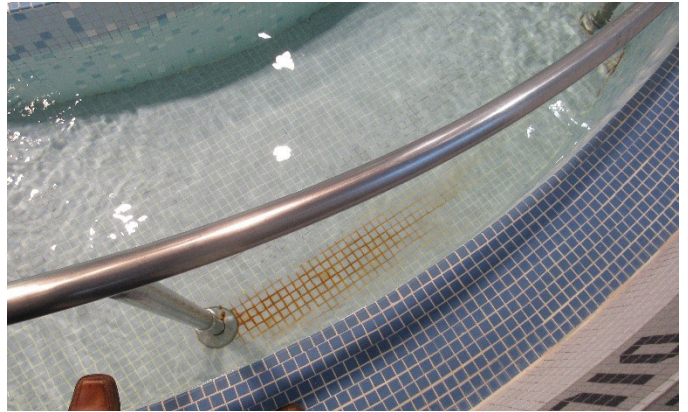
Spot of corrosion in whirlpool. Potentially from a deposit of rust or corrosion of the pool vessel from under grout.

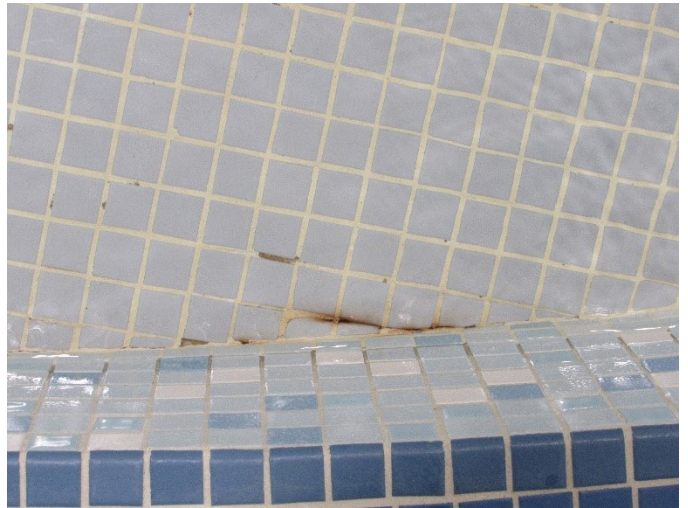
Location of corrosion in whirlpool. Potentially from corrosion from the pool vessel or nearby handrail/anchor.

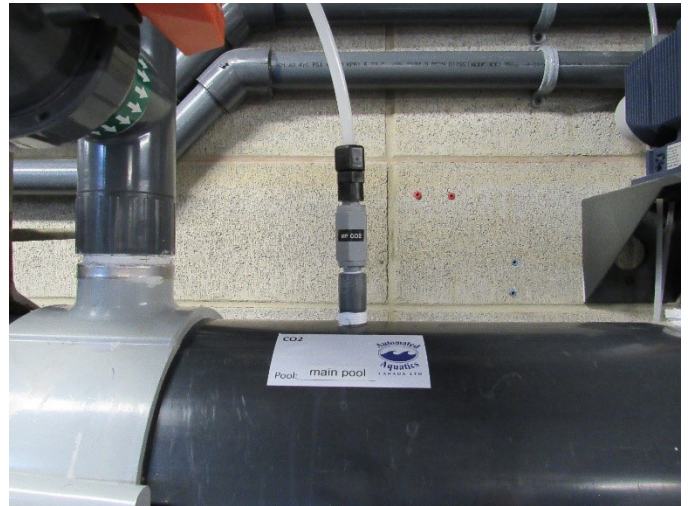
Mineral buildup on one fitting for the main pool Hydroxan supply. Check for minor leaking.

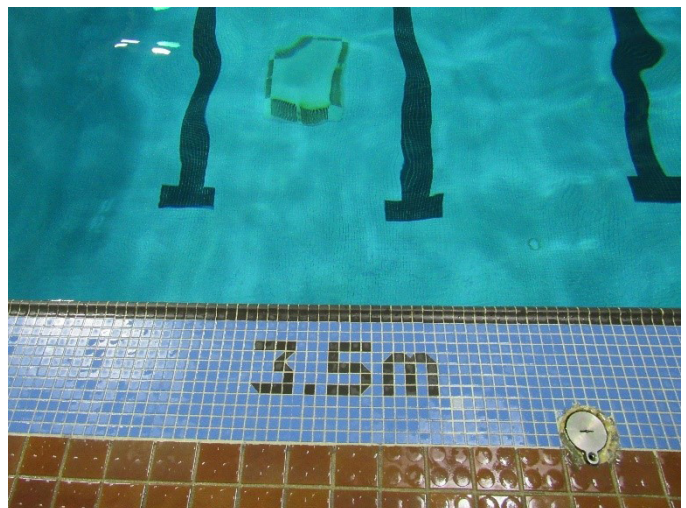
The colors of the pool floor tile in the shallow area of the pool are several shades of blue. Alberta pool regulations require the pool basin to be white. The pool was originally designed permitted with this color pattern; therefore some level of “grandfathered” status likely exists to allow the tile to remain. However, any future tile repairs or replacements should be completed with white tile only.
