June 11, 2015
Project No. 214320

CITY OF FORT
SASKATCHEWAN

GOLF & CURING CLUB
FACILITY EVALUATION REPORT

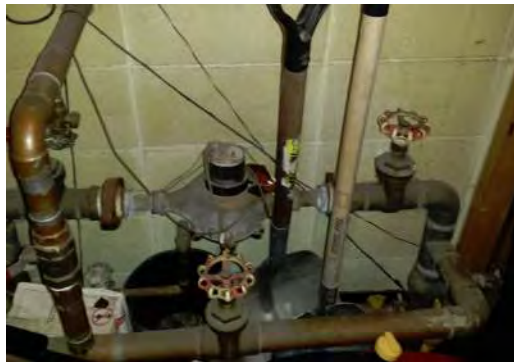
The Arena has its own dedicated 50mm diameter water service. There are backflow prevention devices installed on the line to the domestic hot water.

Figure 1: No Backflow Device @ Water service

Item	Time Frame (Years)	Approximate Cost, Installed
Replace Chiller Plant	0 (Immediately)	\$250,000
Add Backflow Prevention Device on Water Service	0-5	\$12,000
Replace Domestic Hot Water Heater	0-5	\$3,000
Replace Recirculation system	0-5	\$2,000
Convert Fixtures to low flow (IR)	3-5	\$8,000
Replace Furnaces and Kitchen Makeup Air	3-5	\$25,000
Replace Gas fired Unit heaters	5-10	\$10,000

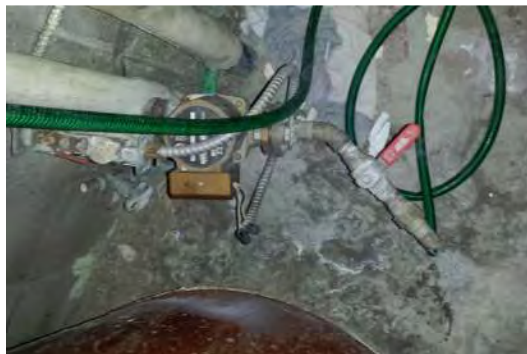
A domestic hot water re-circulation system is provided to ensure timely delivery of hot water to the plumbing fixtures. The existing recirculation unit to the tank has been disconnected and is currently out of service. It is recommended that the recirculation system be replaced with the domestic hot water system replacement.

Figure 3: Domestic Hot Water Tank Disconnected Recirculation System

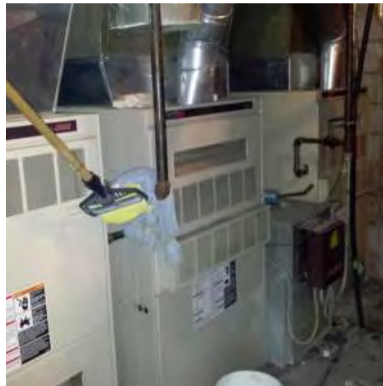
The facility utilizes a total of 4 furnaces to service the building. Three main furnaces are located in the main mechanical room and services the lobby, the main floor spectator area, the upper lounge and kitchen. The fourth furnace resides in the west side of the facility which services the west upper lounge area. The main furnaces are identical (heating only) with a heating input of 150MBH each and the fourth furnace with an input of 115 MBH. Ductwork distribution could not be reviewed to determine the condition however some of the existing distribution was noted to be buried ductwork. Consultation with facilities indicated that no concerns regarding standing water in the ductwork has been overserved over the years. Replacement of the furnaces should include a study to verify that current codes and standards for minimum ventilation rates are satisfied.

Figure 4: Main Furnaces

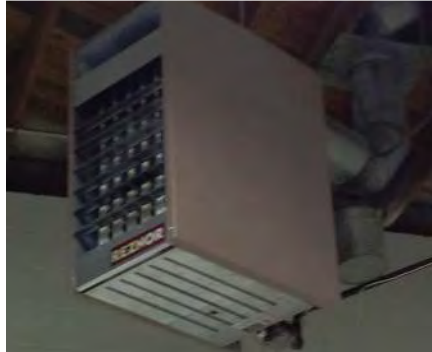
The curling rink is serviced with four gas fired unit heaters at each corner of the rink. Nameplate data could not be attained from the units due to accessibility limitations. Two of the four unit appear to have been replaced from original. The units appear to be in fair to good condition.

Figure 7: Infrared Heaters

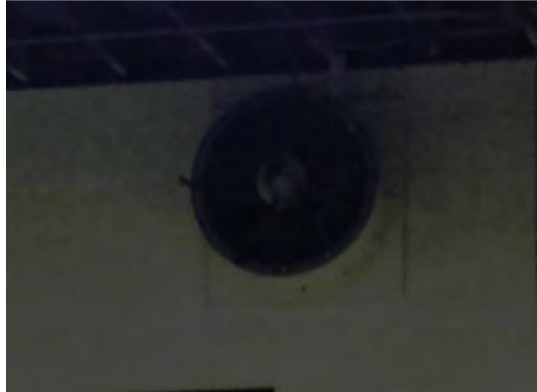
The curling rink is serviced with two ventilation fans exhaust fans paired to two intake louvers located on the opposite side of the curling rink. Access to the unit was limited and the nameplate data could not be accessed to verify capacity. Any updates to the ventilation units should include a study to confirm that the current code requirements for ventilation are satisfied.

Figure 8: Ventilation Fan

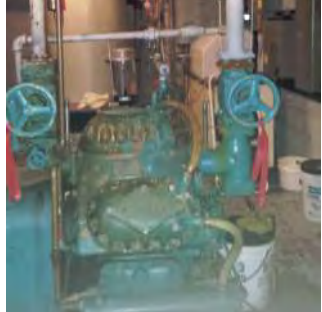
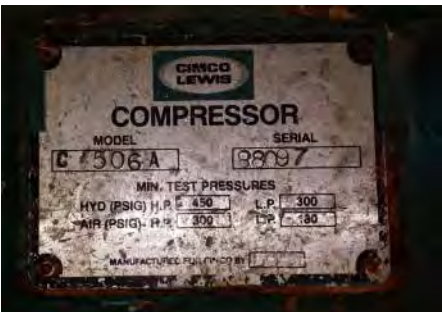
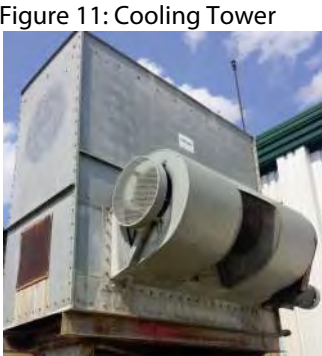
The main ammonia chiller plant is located within a dedicated room that has refrigerant monitoring and alarms. The chiller plant utilizes a water cooled system that incorporates original equipment such as: Cooling Tower, water conditioning equipment, CIMCO reciprocating compressors, belt driven with motors, shell and tube heat exchangers and distribution pumping. The chiller plant had recently suffered a catastrophic failure and has been decommissioned at the time of review. Due to the age of the equipment, it is recommended ALL original equipment be demolished and replaced with a new air cooled chiller plant complete with digital controls and refrigeration monitoring system.

Figure 10: Chiller plant
