**RE: City of Fort Saskatchewan Indoor Facilities Services Review: Process update memo #1**

The 2023 Harbour Pool Assessment Report (under separate cover) provides an overview of the current state of the facility. Lead by ACI Architecture and conducted by a multidisciplinary team of engineers and architects, the Report addresses structural, mechanical, electrical, and architectural considerations of the facility and the potential for expansion. The Report also includes an assessment of the aquatics components of the facility interpreted by an aquatics specialist (WTI). This aquatics assessment includes a review of the technical aspects of the natatorium and waterworks and includes some insight on functionality and limitations.

FEBRUARY 10, 2023

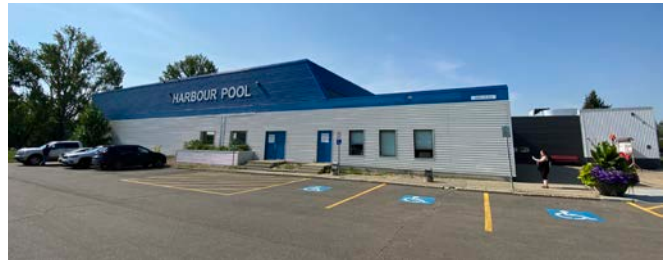
Photo 1: Harbour Pool East Facade

Exit man doors in the East elevation are significantly higher than the exterior concrete sidewalk. Stairs and railings have been added to these locations to accommodate access. This access, however, does not meet Barrier-Free requirements. Man doors located along the South facade have no concrete stoop and have a substantially vertical drop from the door sill to the grade. South and West elevations all appear to have concrete stoops at Exits.

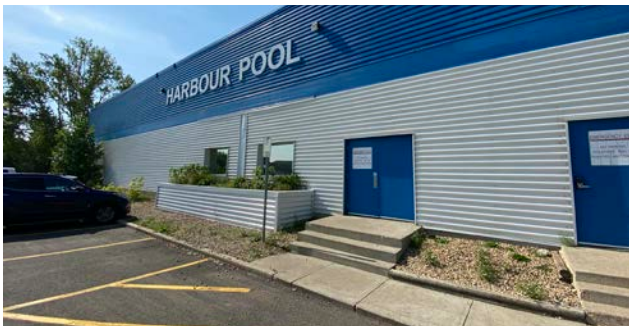
Photo 2: Planters

Planters are located below the windows on the east elevation. They are inspected to be in acceptable condition. The exterior finish is metal cladding which matches the facility's cladding.

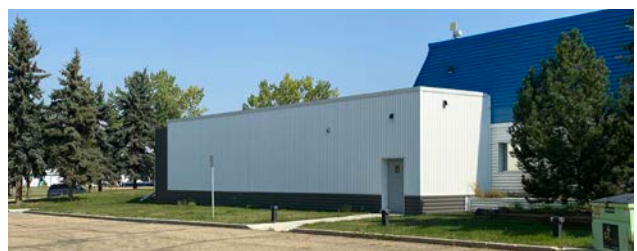
Photo 5: Universal Change Room Addition

The visual inspection of cladding located over the 2019 universal change room expansion are in excellent condition.

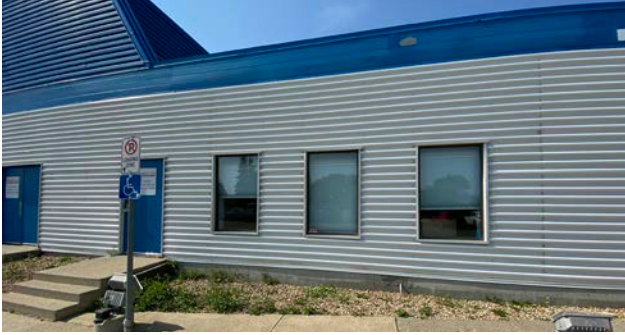
Photo 5: Exterior Wall + Windows

Below grade consist of cast in place concrete walls. These concrete walls show signs of patching along the east face. The walls appear to be in acceptable condition and are maintained regularly.

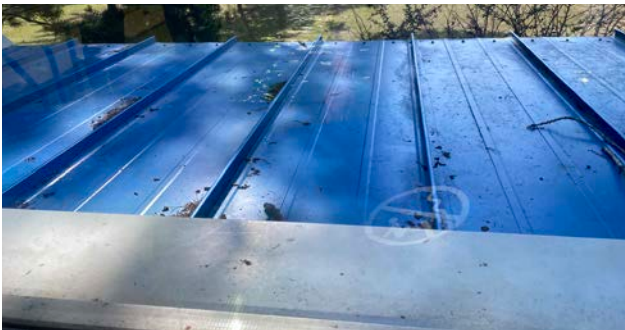
Photo 6: Standing Seam Roof

The sloped metal standing seam roof is reviewed as in excellent condition.

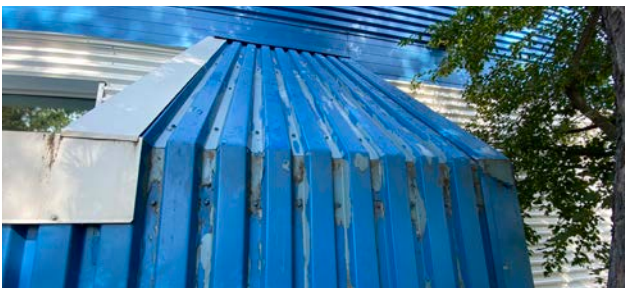
Photo 7: Sloped Standing Seam Roof

The sloped cladding at both sides of the standing seam roof are in poor condition, paint delaminating and exposed raw steel is visible throughout. Recommendation is to replace the cladding with a more suitable material for slopes and water shedding. *(Refer to Costing and Facility Condition Analysis Rating in [Appendix F Section 4.0.](#))*

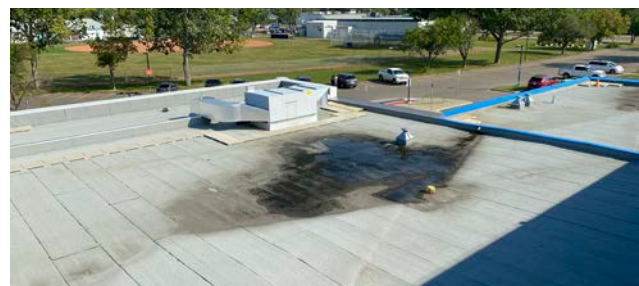
Photo 9-10: Ponding on Roof

The roof on both the original and addition portions are SBS roofing system. In general, the sloping to drain is in acceptable and good condition, however, there are spots where ponding is occurring. Based on discussion with the maintenance facility, remediations have occurred on the lower roof to install additional drains to alleviate some ponding. The ponding in general is minimal and expected on a facility of this age.

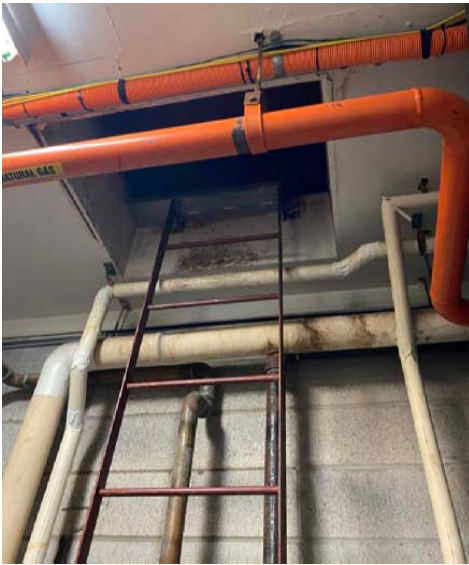
Photo 12: Exit Ladder

The roofs are accessed by a ladder located within the second floor mechanical room. The exit from the ladder is equipped with parapet mounted railing.

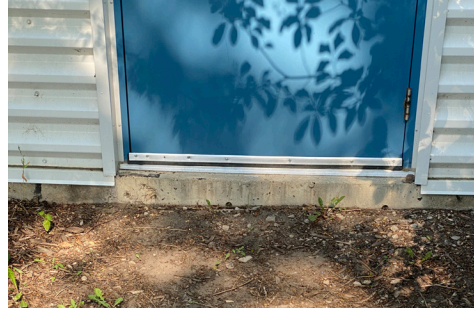
The exterior door located along the south wall second from the west corner is recommended to have sill flashing installed at the concrete top to prevent water penetration into the facility. Currently a threshold is installed below the door, however, the concrete backslopes towards the doors.

Photo 13: Exit Door with significant drop

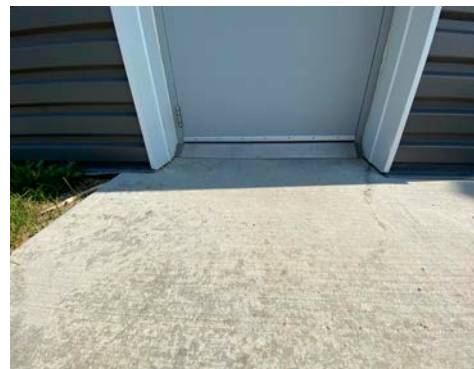
The exterior doors located along the addition west facade is visually inspected to be in good condition. However, upon inspection, the sill indicates to have a significant slope transition that is recommended to be altered to allow for ease of exiting.

Photo 15: Exit Door with significant slope transition

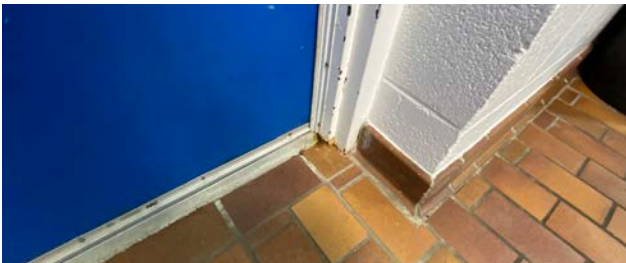
The interiors of some exterior doors indicate signs of corrosion and damage, due to the moisture and water penetration. The exterior door frames are original to the building.

Photo 17: Corrosion on Doors

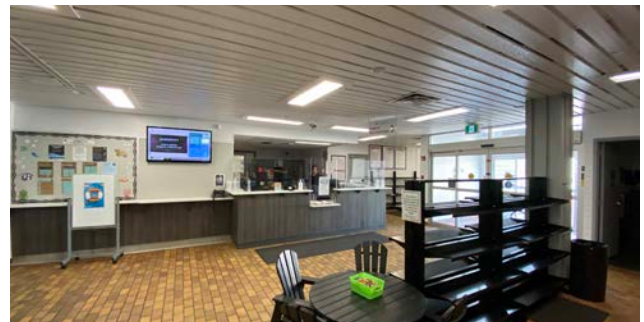
Photo 20: Lobby

The administration desk area was renovated to include new flooring and ceiling in 2005, upgraded administration desk millwork in 2020 with glass screening. Upon visual review, the administration is in good condition.

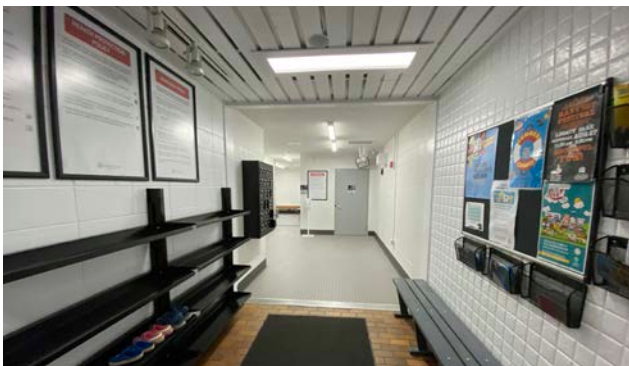
Photo 22: Transition Area

Based on visual inspection of the tile floor where there is a transition from change room to lobby area, evidence shows floating of tiles which is a cause of major concerns. Due to the thickness of the floating areas, there is a ledge created at the entrance that does not allow water to drain. No drains are located within this area which will cause water pooling on the natatorium side and creates a safety concern around slips and falls. Recommendation would be to investigate floating tile and possible drainage solutions. *(Refer to Costing and Facility Condition Analysis Rating in Appendix F Section 5.0.)*

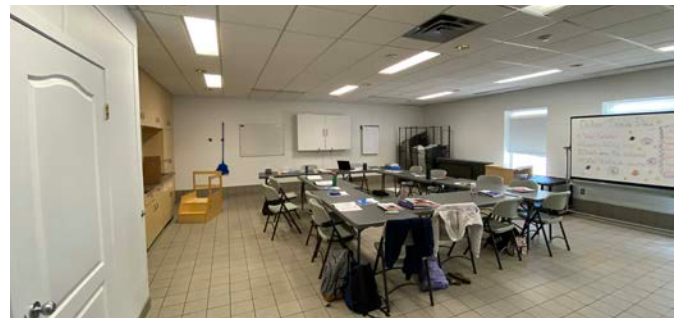
Photo 25: Multipurpose Room

The multipurpose room is visually inspected as good condition. Flooring demonstrates replacement of new tile. Some areas show remediation of tile cracking/damage. Extensive millwork has been added to the room. Millwork is in good condition.

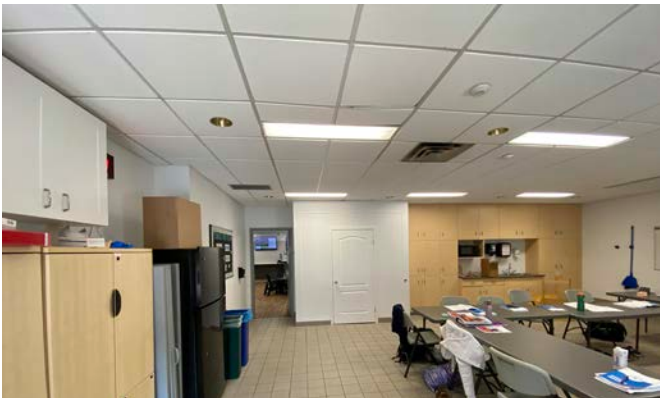
Photo 26: Ceiling in Multipurpose Room

The ceiling tile and grid system were replaced in 2005. However, there are multiple areas of damage to the grid system. It is recommended to be repaired or replaced, refer to photo 26.

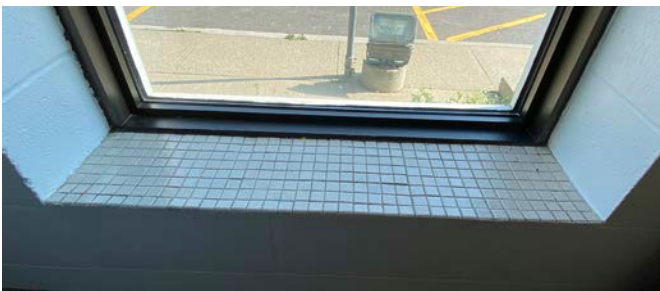
Mosaic tile is installed on the interior window sills. The tile is mostly in good condition, however, there is evidence of shifting and misalignment of tile in some areas. These may be due to substrate levelness or water penetration and would require further analysis. Recommendation is to further investigate this area.

Photo 27: Mosaic Tile Misaligned

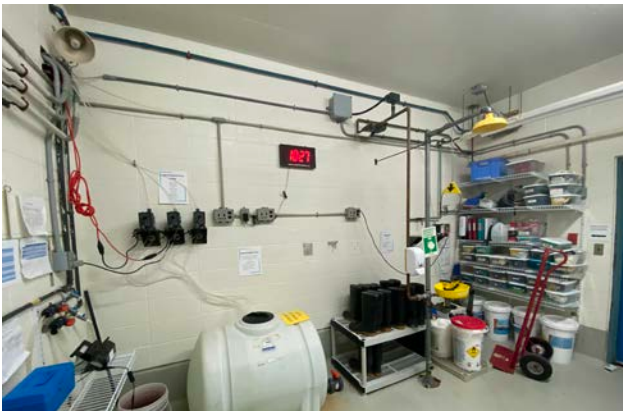
Photo 45: Pool Storage

Pool Storage is accessed from the Main Floor Mechanical room. The pool storage room consists of epoxy coated concrete floor, painted concrete ceiling, and painted concrete block. The review of the room finishes are in good condition.

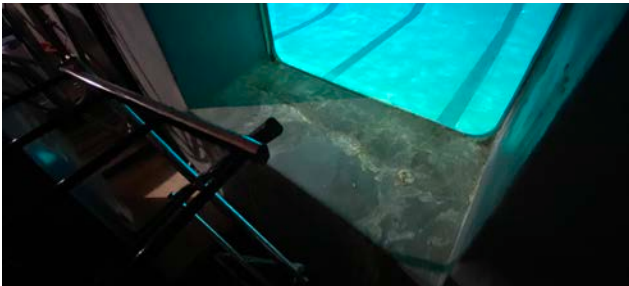
There are windows with sight lines from the basement directly into the pool basin. There are areas of saturation on the window sills. The recommendation is to replace the windows in conjunction with the pool tile basin replacement. *(Refer to Costing and Facility Condition Analysis Rating in [Appendix F](#) Section 5.0.)*

Photo 49: Window Saturation

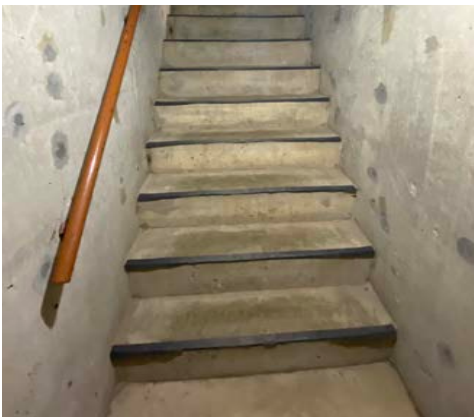
Photo 50: Basement Stairs

The stair access to the basement is steep. Based on the construction year the stairs are acceptable and considered "grandfathered". However, if major modernization was to occur the recommendation would be to replace the stairs with code conforming rise and run.

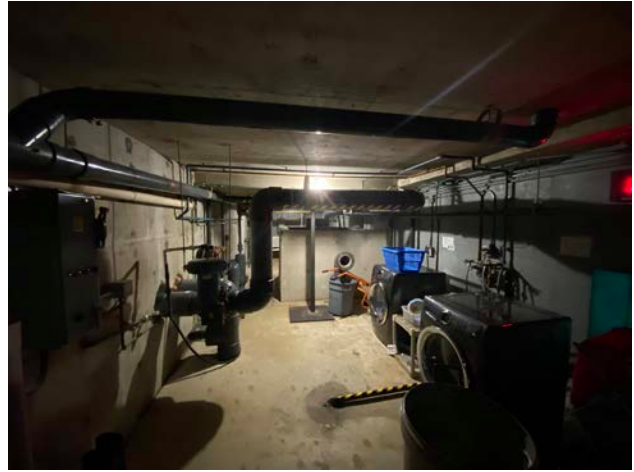
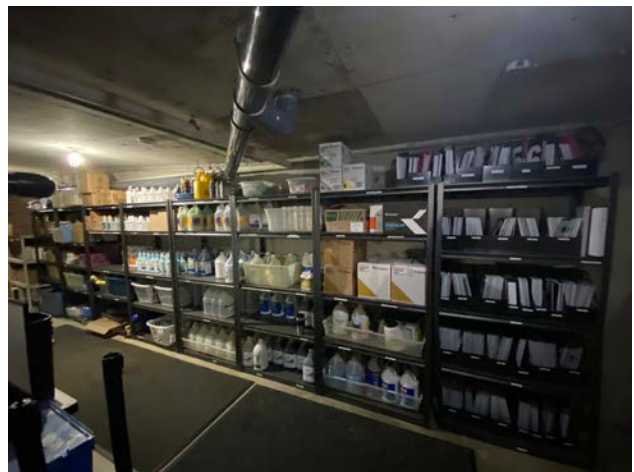
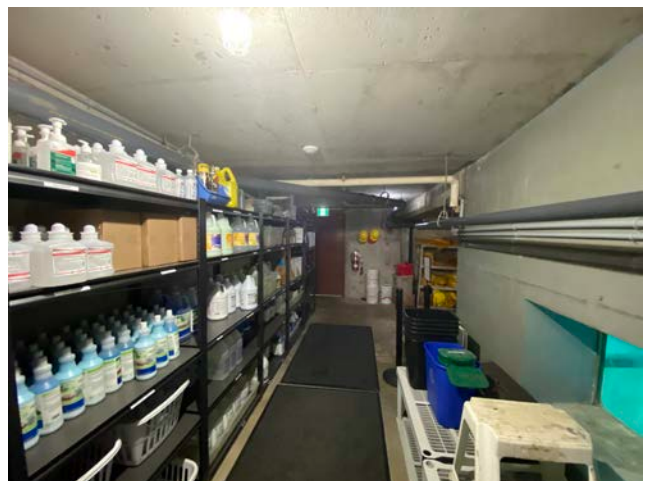
Photo 51-53: Basement Storage Room

The storage and washing area are located directly within the basement. The storage contains cleaning supplies and aquatics accessories. The cleaning supplies are non-flammable. The washing area consist of one washer and one dryer.

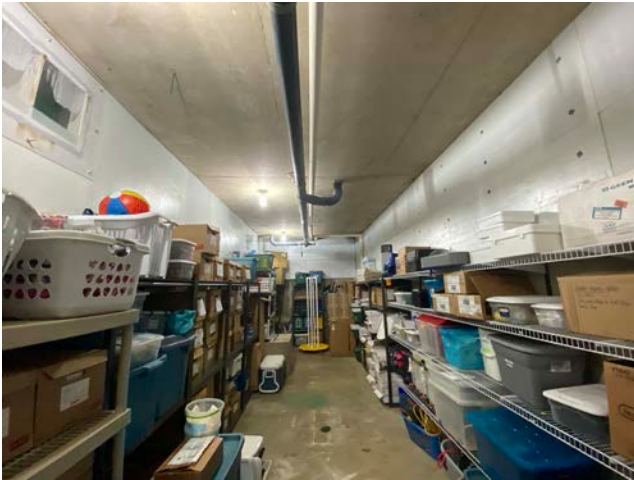
Photo 54: Storage

Through inspection, the storage room contains archive administrative files, paint, building supply storage, and miscellaneous storage. The door accessing the storage room is not evidently to be rated. The recommendation is to replace the door with a fire rated assembly. Any penetrations through the storage room walls and floor should be fire caulked and sealed.

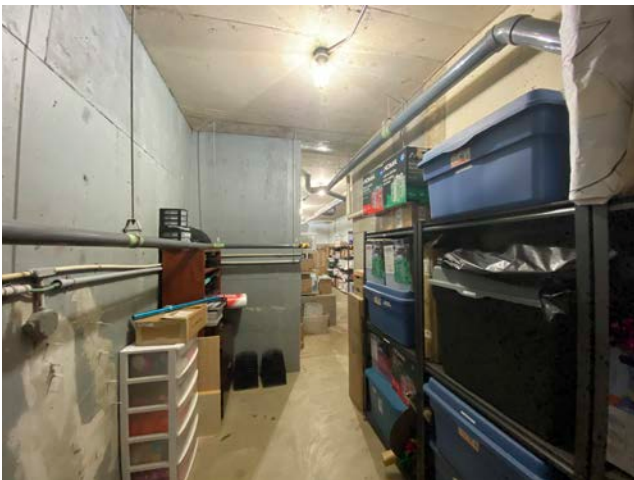
Photo 55: Storage with Bump Outs

The walls within the storage room have insulation installed above six feet. This is in reference to the wave generator and exterior walls.

Within the storage room there are two bump outs from the concrete floor, where the wave equipment would have been mounted. Above this area show signs of water

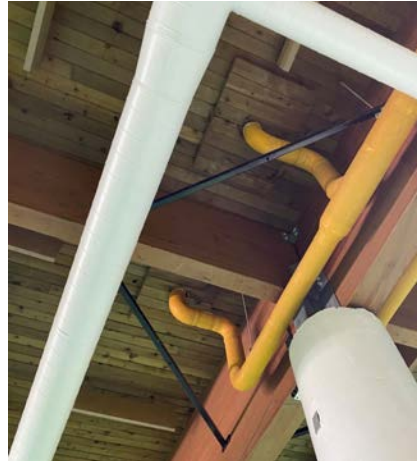
Some minor staining was noted on the wood deck at the roof drains (Photo 1).

Photo 1: Minor staining on the roof deck at the drains

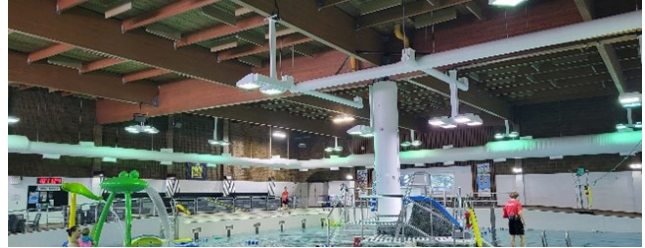
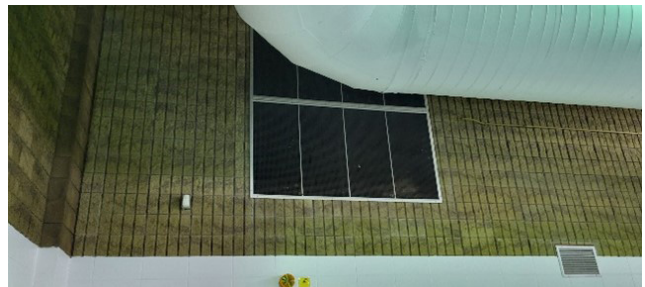
The mechanical heating, ventilation for the pool space is provided by one large air system located in the upper level

mechanical room with an exposed duct distribution system around the perimeter of the pool to various diffusers and grilles. A large return air grille on the mechanical room wall draws the air back to the air system.

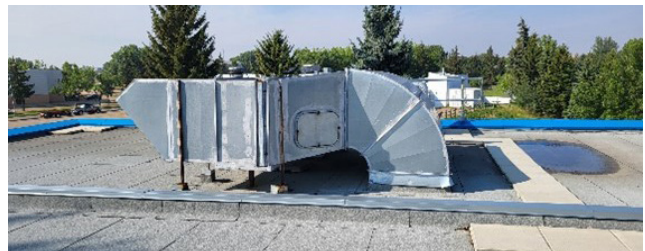
The existing pool air system was replaced with another air system in 2004 and would appear to be in good operating condition. The air system consists of supply fans, gas fired heat section, filters and appears to be regularly maintained. It would appear that a heat recovery run around glycol loop has been installed to recover the waste heat from the pool exhaust and return the heat back to the outdoor air intake for the pool air system. No plans or details were available at the time of the site visit.

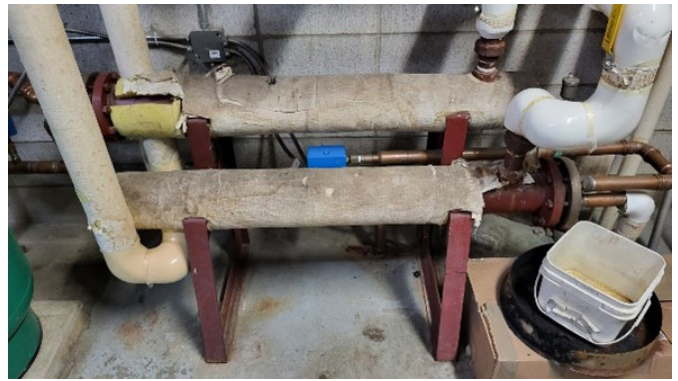
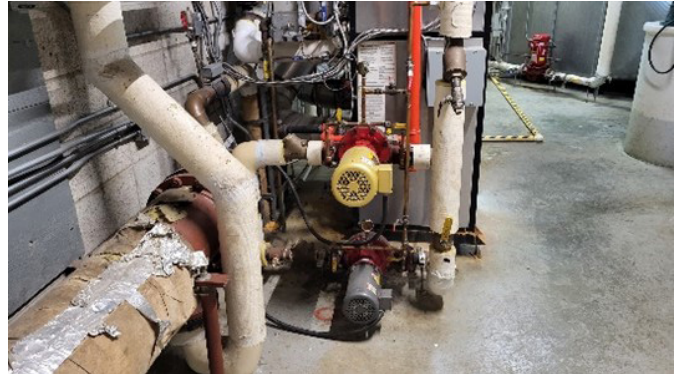
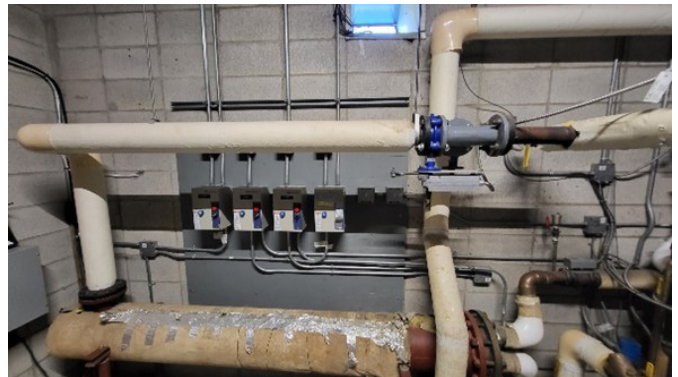
The pool and building heat exchangers appear to be in fair operating condition and have been regularly serviced with minor repairs to the copper piping connecting to the heat exchangers. The insulation on the heat exchangers is not in good condition and should be replaced with new.

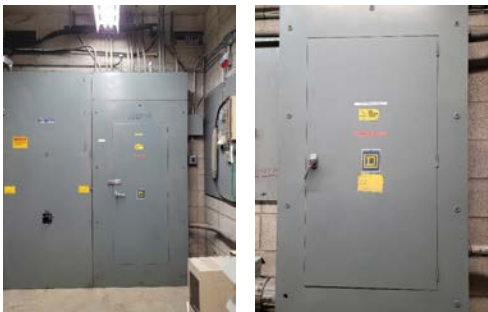
The mechanical starters are well labelled; however they appear to be original to the building and have reached the end of their expected service life. Life-cycle replacement of the starters should be considered at this time. (Refer to *Costing and Facility Condition Analysis Rating in Appendix F Section 11.0.*)

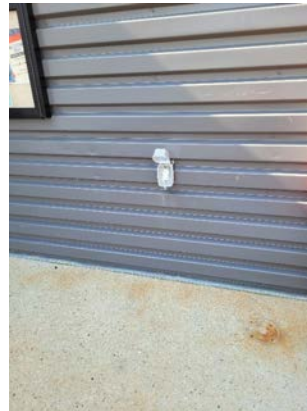
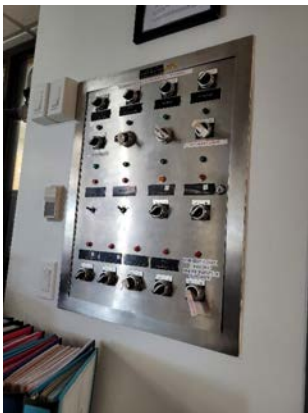
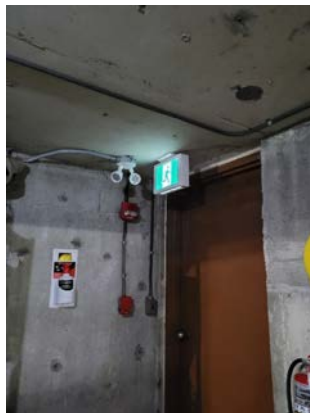
The exterior receptacles have been upgraded to have the new in-use style weatherproof covers. Two of the covers were laying on the ground when we were on site. The covers should be re-attached to the junction boxes, and if damaged should be replaced.

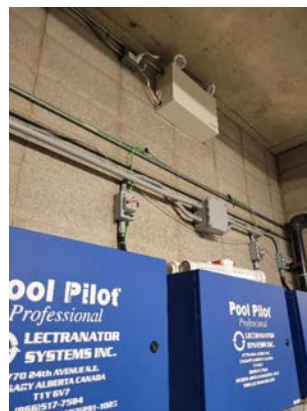
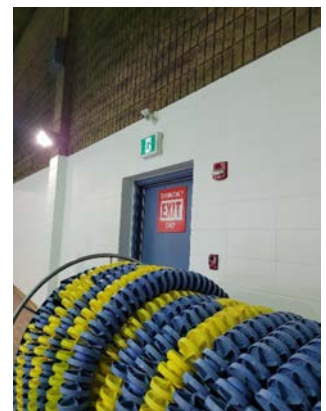
Emergency lighting is provided by emergency battery packs complete with LED heads and additional remote LED heads were needed. All equipment appears to be in excellent condition. The emergency lighting battery pack in the filter room has a yellow caution LED illuminated and should be investigated and repaired if required.

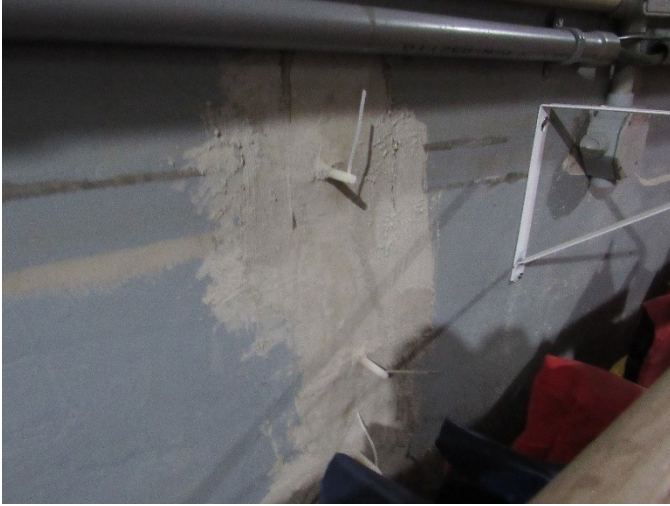
The main pool concrete pool vessel has had some cracking, and potentially leaking. These cracks are visible in the subgrade mechanical and storage spaces partially around the pool vessel. However, it appears all visible cracking has been properly repaired.

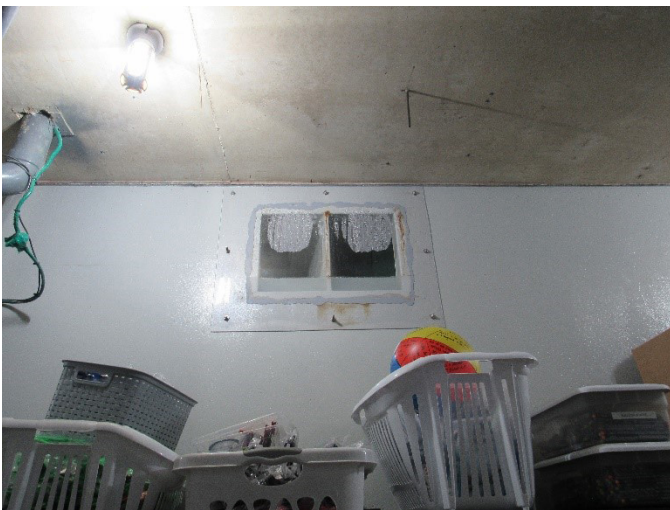
The pool was originally constructed with wave caissons and blowers to generate wave actions in the pool. However, staff reports this wave system could not be used without overflowing water beyond the beach entry and flooding the deck. Operation of the wave system was ceased shortly after original construction and has not been used since. Blowers have been removed and the associated openings to the top of the wave caissons has been covered.

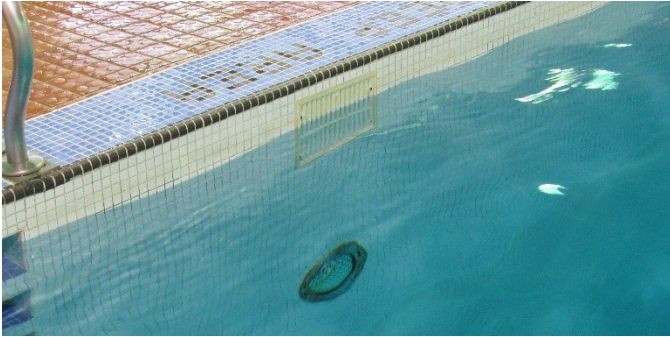
Surface water is collected in the main pool and whirlpool using in-wall skimmers with vertical grating. This method of water collection is inferior to a perimeter gutter with respect to the ability to remove contaminants from the water surface. Furthermore, accessing the skimmers to clean debris or repair damage is inconvenient as there is no top access from the deck.

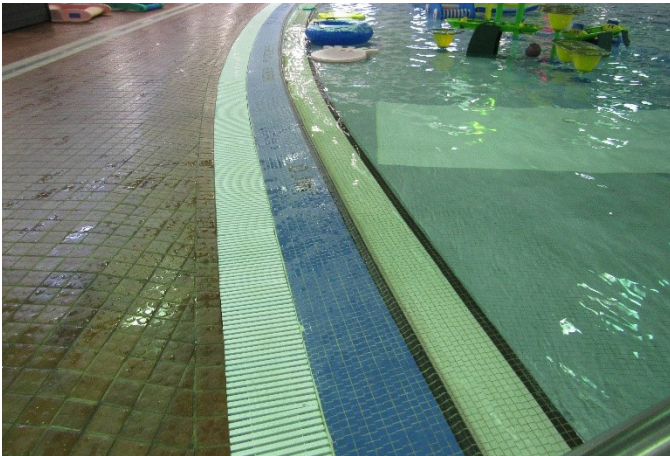
A gutter is constructed along the edge of the beach style entry of the shallow area of the pool. However, this gutter is not designed for continuous surface water collection, and the pool water, at normal operating levels, does not reach this gutter. The gutter was installed to collect overflow from the operation of the wave generation system (which is no longer in use).

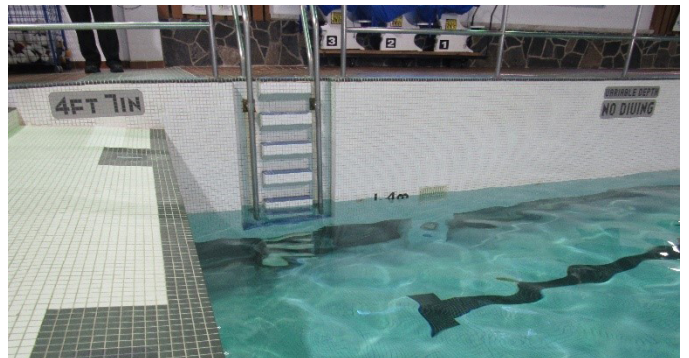
Due to the construction of wave caissons, two sizes of the main pool in the lap lane area are raised high above the water level. This creates an extremely high vertical distance from the pool water level to the pool deck. While pool ladders in this area are code compliant, egress from the pool water in these areas is difficult and dangerous for any user without sufficient physical climbing abilities. Without a functioning wave system, this deck height and difficulty in pool exiting is unnecessary.

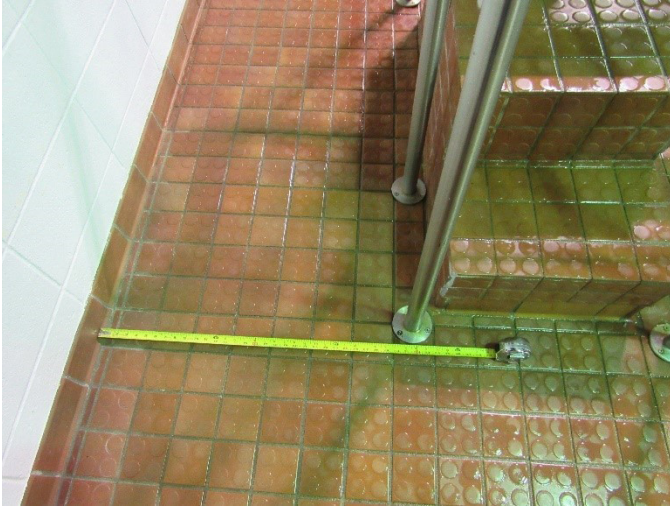
The deck clearance behind the diving stand, or distance between the wall and diving stand, is insufficient and not code compliant. There needs to be a minimum of 0.9 metres, or about 3 feet, of unobstructed clearance behind the diving stand.

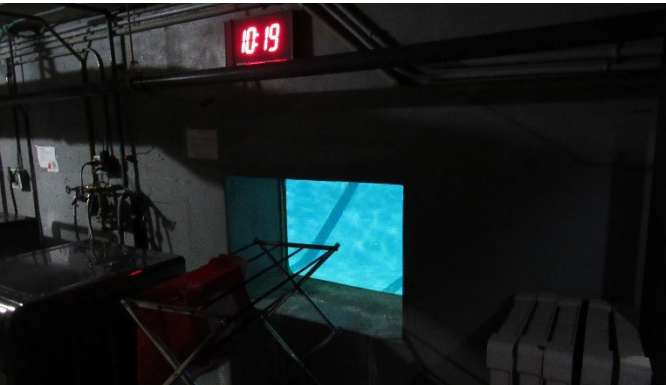
The main pool has two underwater viewing windows. Some efflorescence existing around and in the opening to the window, but both windows appear to be in good condition. The concrete and seals around the windows should be monitored frequently to prevent failure.

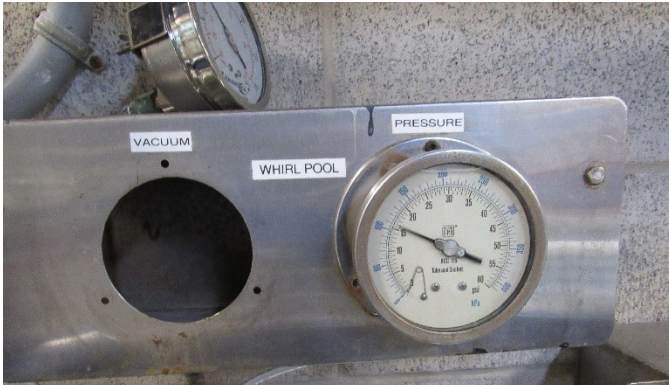
Vacuum gauge for the whirlpool is not installed or functioning. Pressure gauge is installed. Pressure and vacuum gauges for the main pool and warm pool are functioning.

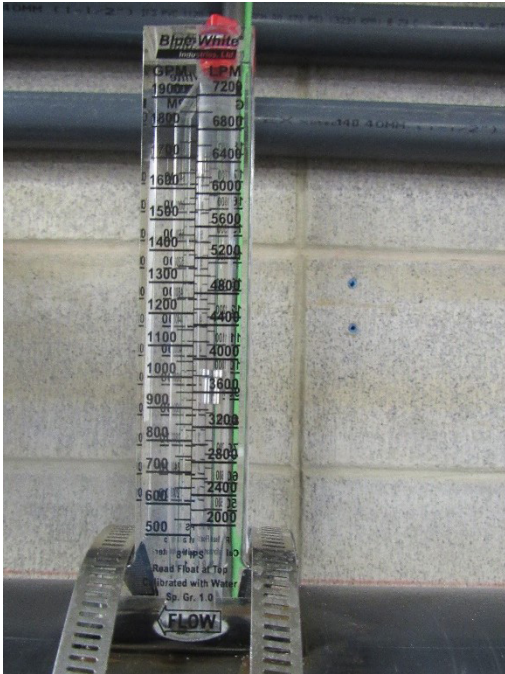
Analog flow meters are functioning and visible.

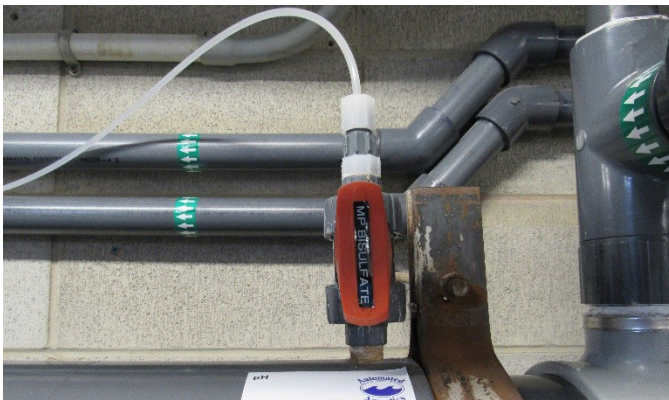
Chemical injection points for carbon dioxide and sodium bisulfate are clean and functioning.

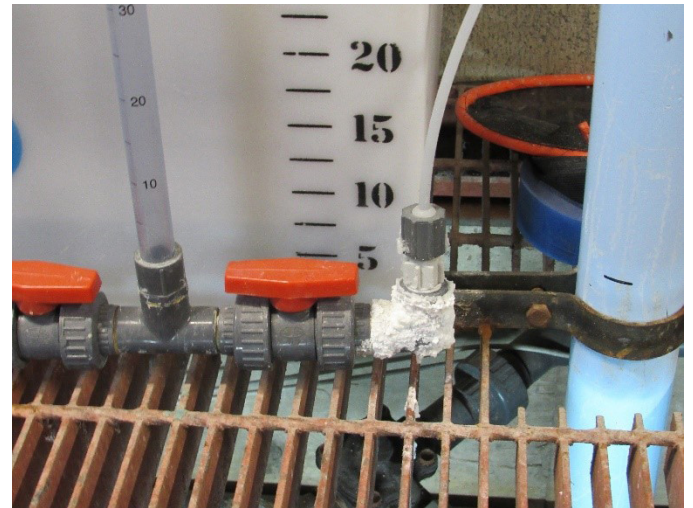
Mineral buildup on one fitting for the main pool Hydroxan supply. Check for minor leaking.

### CLEAN AND REPAIR MAIN POOL HYDROXAN FITTING

Mineral buildup on a fitting on the injection tubing for the Hydroxan solution of the main pool should be cleaned and the fitting inspected for leaking. Mineral buildup on these types of chemical fittings is common, and not a cause for concern unless due to significant leaking, which would typically result in a much great amount of chemical crystallization on the fitting. If leaking is evident, the fitting should be replaced.

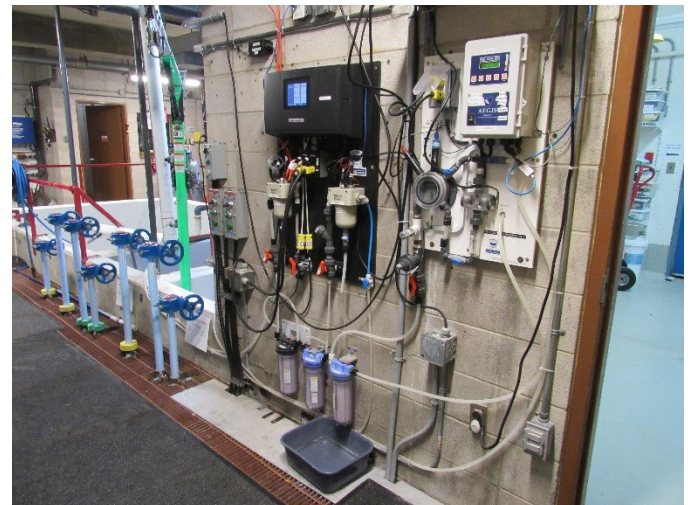
Chemical controllers are functioning and appear accurately calibrated.

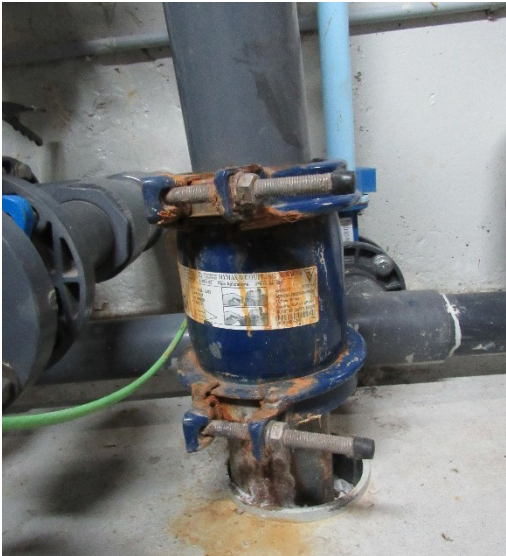
Piping, fittings, and valves of the pool circulation system are in good condition with a few exceptions. There are three couplings on drain lines in the pump pit will significant corrosion. Replacement is necessary.

### REPLACE CORRODED PIPE COUPLINGS

Three steel pipe couplings in the pump pit are badly corroded and should be replaced. Corrosion on the piping components increases the risk of component failure and potential flooding of the pump pit. The couplings should be replaced, preferably with PVC fittings.

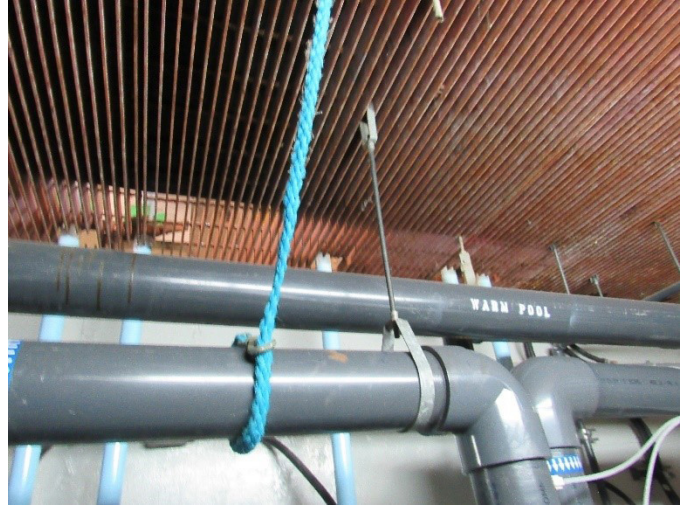
Pool piping hangers and supports are in good condition with one exception: in the pump pit one horizontal section of pipe is partially supported with rope. Steel hangers should be installed to properly support the piping.

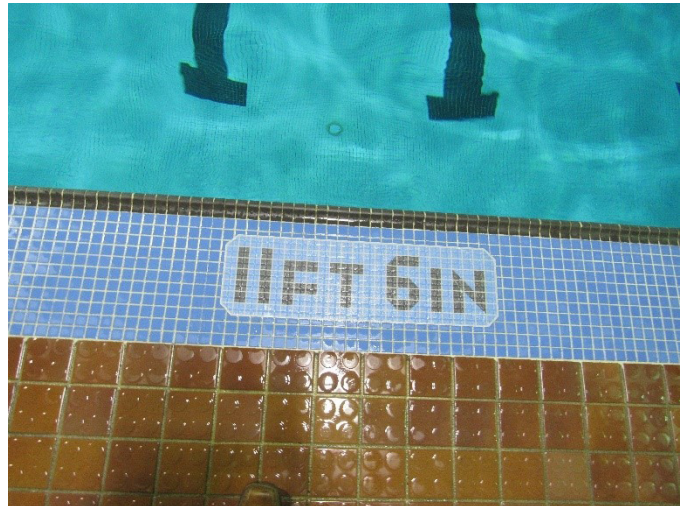
Pool depths are properly marked in both metric and imperial.

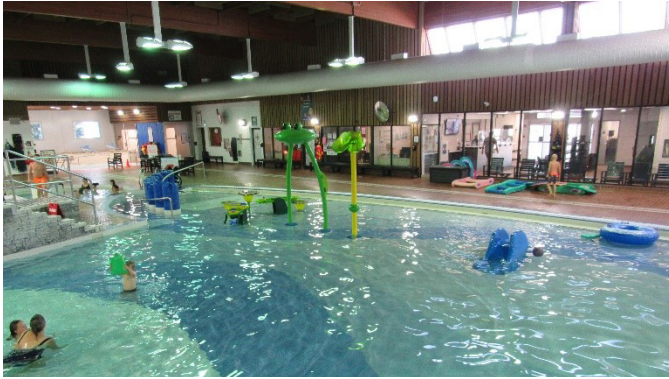
The colors of the pool floor tile in the shallow area of the pool are several shades of blue. Alberta pool regulations require the pool basin to be white. The pool was originally designed permitted with this color pattern; therefore some level of “grandfathered” status likely exists to allow the tile to remain. However, any future tile repairs or replacements should be completed with white tile only.

### REPLACE POOL TILE FINISH
