June 11, 2015
Project No. 214320

CITY OF FORT
SASKATCHEWAN

GOLF & CURING CLUB
FACILITY EVALUATION REPORT

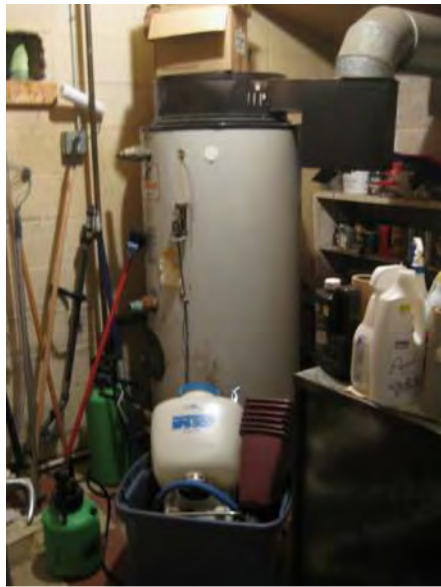
Mechanical Room #12

Some floor stains were noticed in the Mechanical room, but are of no structural concern here. Also, noticed the roof portion of this room, which showed some stained area, probably due to water leak from a pipe as the area above was not accessible.

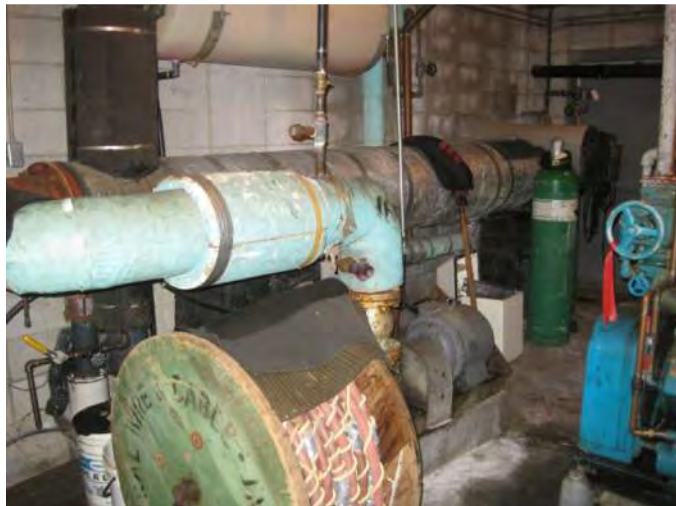
Ice Plant #14

The roof itself and associated flashings were beyond the scope of this visual review but it should be noted that a significant water leak was seen dripping from the ceiling of the ice plant during a rain event back in 2010. BR2 was informed that the roof of this area was upgraded to resolve this issue, and since this repair was completed no further leakage has been observed. The damage left behind from the leaking roof has never been repaired and compromises the fire resistance rating of the roof structure over the mechanical room. Water staining was also noted in several locations throughout the building, however it is difficult to determine if new leaks or staining has occurred since the 2010 report was issued. If these stained ceilings are in areas where no upgrades to the roofing were performed in the past 5 years, it is recommended that further investigations take place to determine their source.

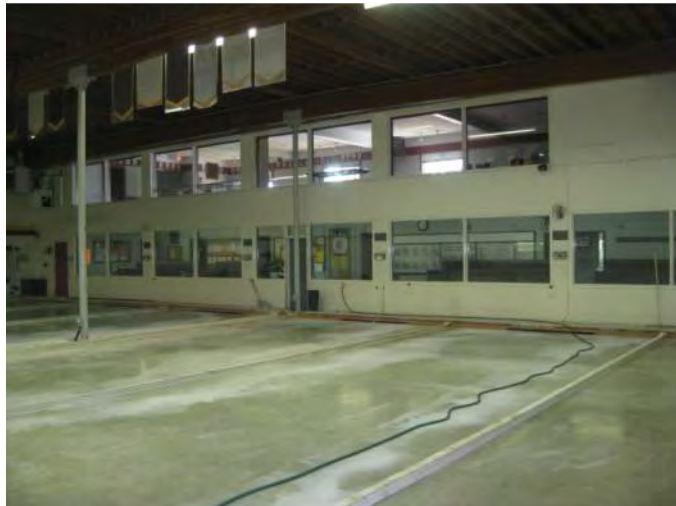
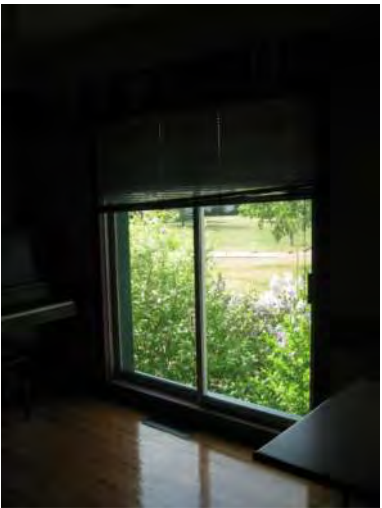
Curling Rink #16

The majority of the rink area construction is exposed structure and has a clear tinted stained finish that is standing up well. Some areas of water staining is evident, however it is not clear if this is from roof leakage or frost build up and melting, no recent recorded leaks were noted. The majority of the remaining areas have a spray texture finish on gypsum board or painted gypsum board. The spray texture finish is in good condition while the remaining areas of painted gypsum board require some touch up and repainting. Some water spots were observed throughout the building. Further investigation is recommended to determine their source. The main entrance lobby has portions of suspended acoustic ceilings. These are in fair condition and tiles can be replaced as required.

Based on the visual observations, the Curling Rink is in reasonably good structural condition. As the wood structural work, in the rink area roofing, needs to be addressed with the roof to be verified and confirmed for proper draining, due to permanent deflection of the wood purlins, the cost estimation suggested would be around \$ 175,000.00. A Structural Engineer registered in the province of Alberta should be retained for the Design and to produce working drawings for this roof remedial works.
