### City of Fort Saskatchewan

#### Sump Pump Retrofit Program Develop Prioritization Criteria Technical Memorandum No. 2

June 2016

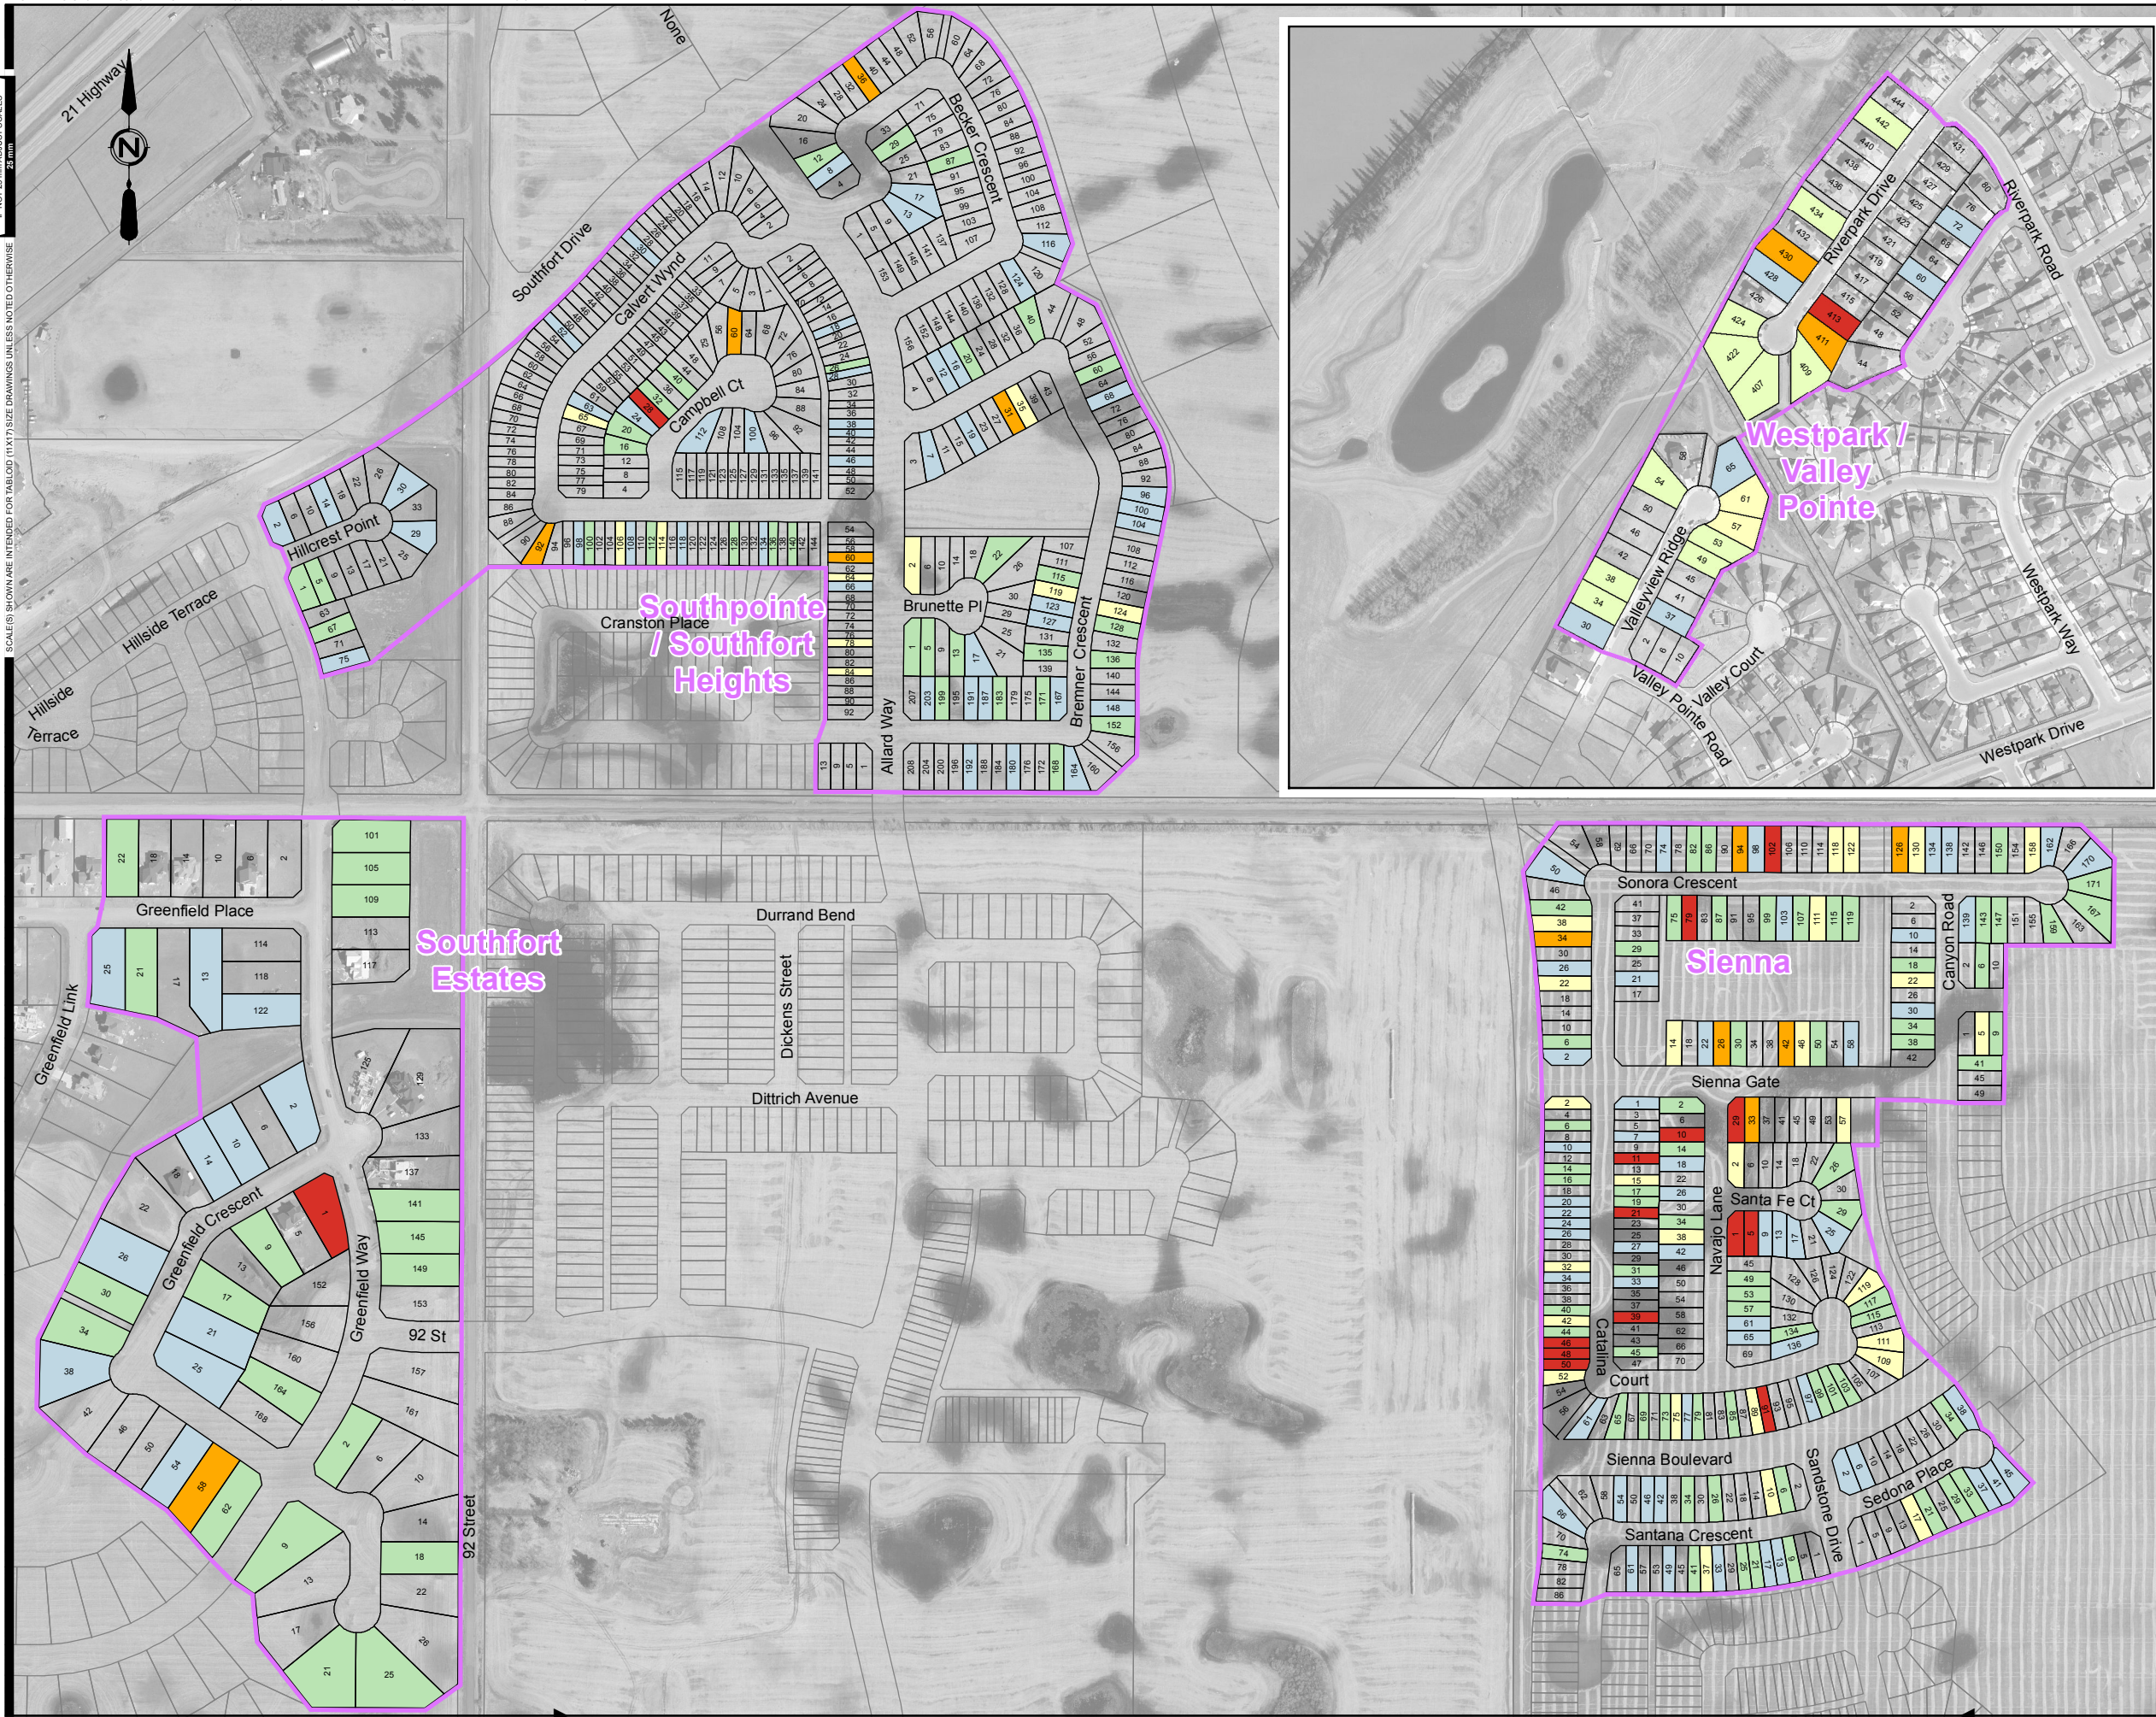
PROPERTY EVALUATION CRITERIA  
SINGLE PROPERTY RATINGS

Legend:

Rating Total

- 3 - 15
- 16 - 30
- 31 - 40
- 41 - 51
- 51+

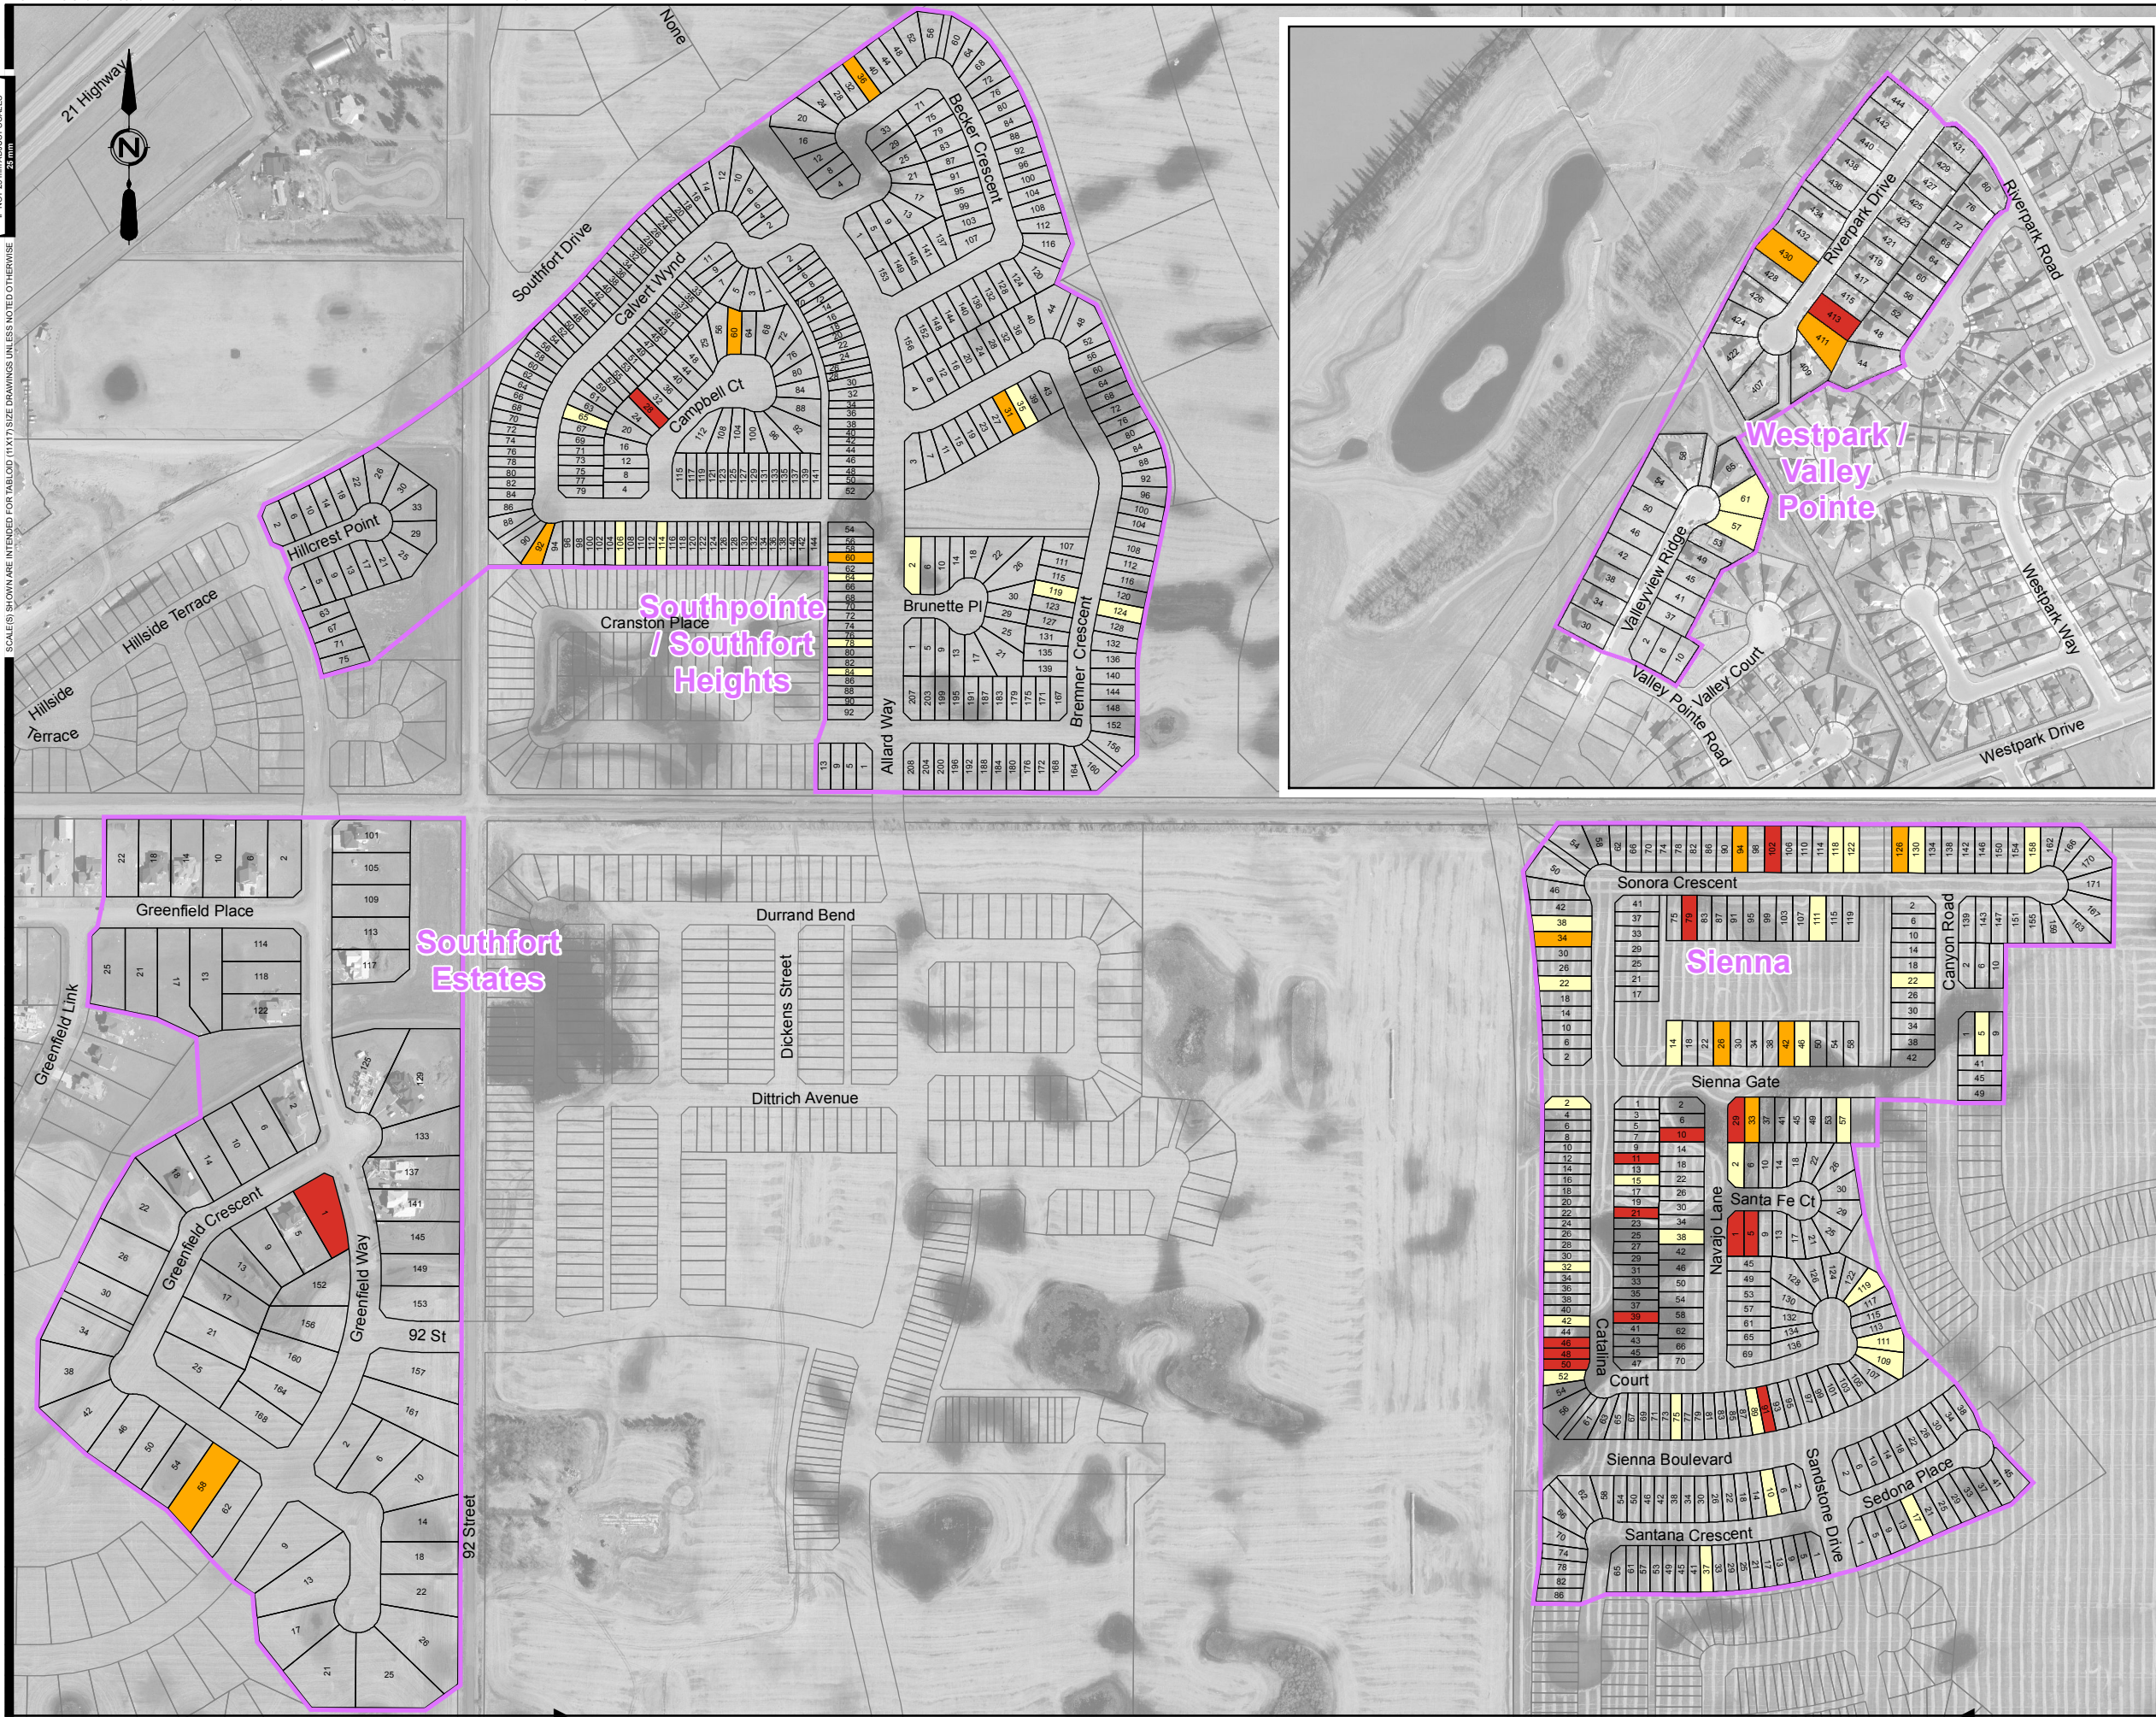
PROPERTY EVALUATION CRITERIA  
HIGHEST SCORING SINGLE PROPERTIES

Legend:

Rating Total

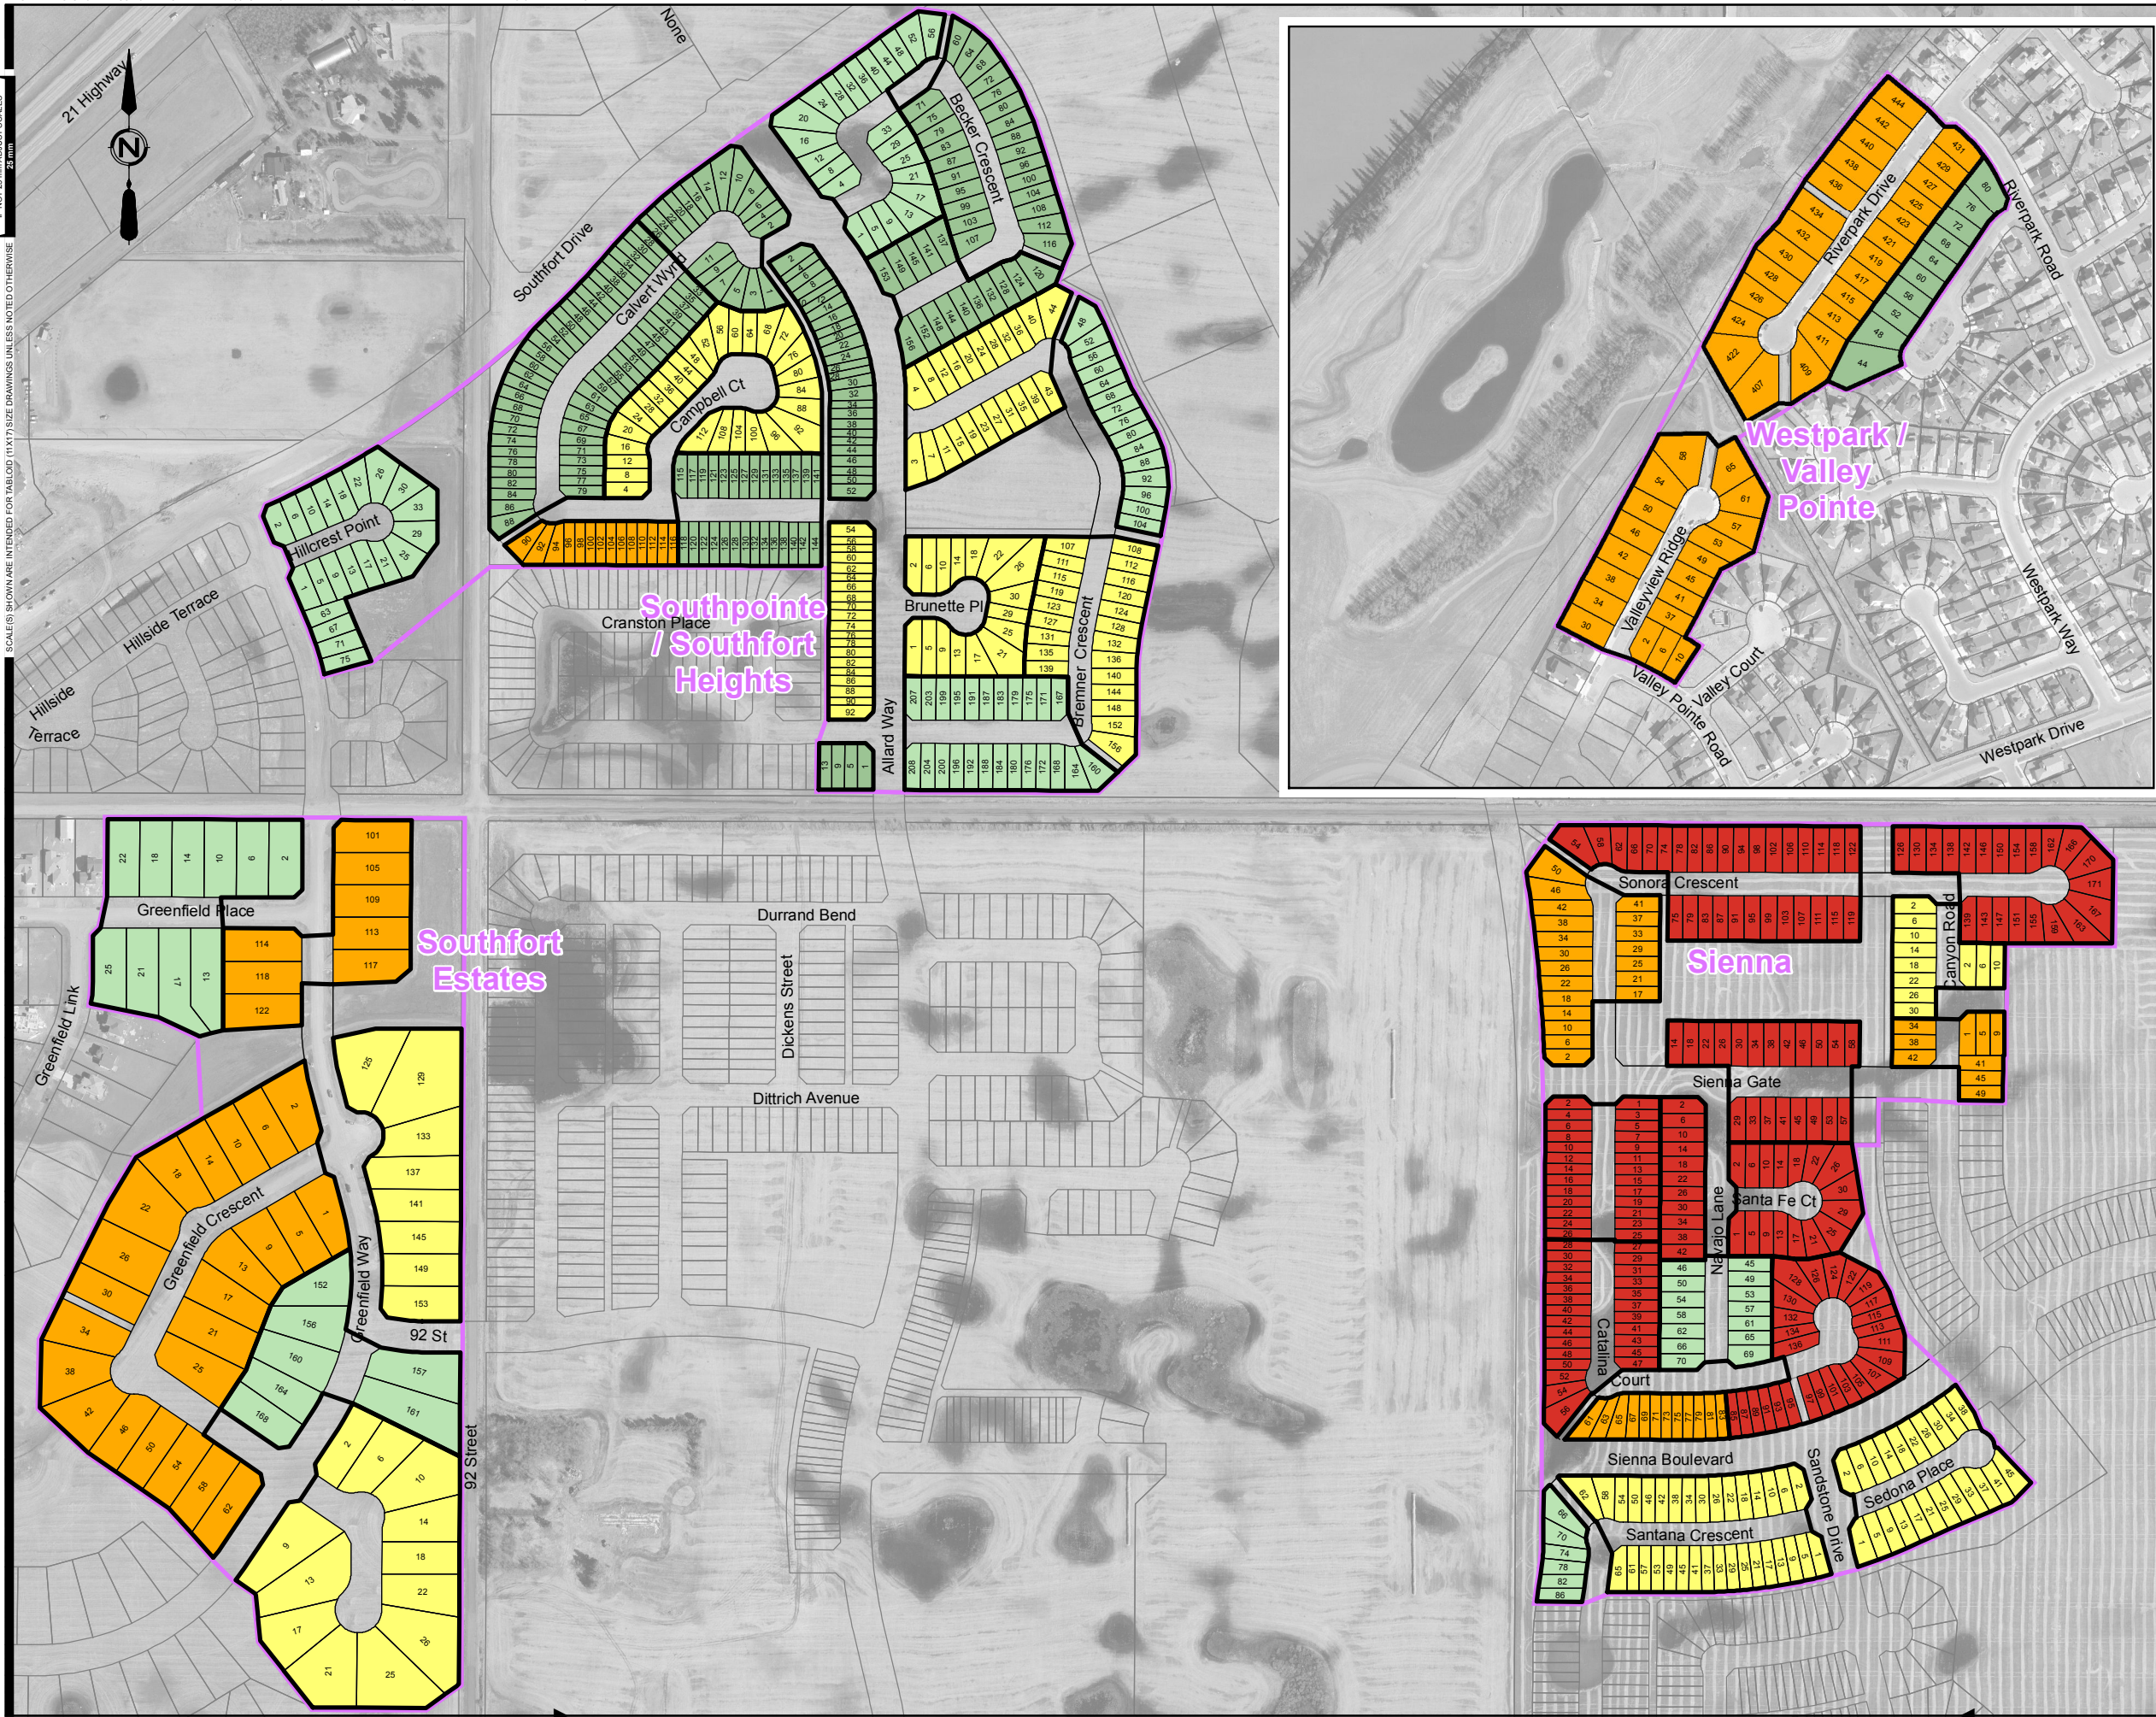
PROPERTY EVALUATION CRITERIA  
PRIORITY BLOCK NUMBERING

Legend:

AverageRating

As noted in Section 3.0, the Sienna neighbourhood has the largest percentage of high scoring properties, and the only eight blocks that had an average score between 14.6 and 21, which was the highest in the Study area. As the City would like to rank retrofits on a block-by-block basis, the eight blocks that scored between 14.6 and 21 should be the first priority in the Sump Pump Retrofit Program. Upon completion of the retrofits of the eight blocks, the analysis and cost estimates outlined below can be used to rank retrofits for blocks throughout the study area with an average lot score between 10.4 and 14.5.
